First Due Home Inspections, LLC
(580) 369-1105

Home Inspection Report
123 Example St
Oklahoma City, OK 73130

Prepared For: Demo Dan
Inspected On Tue, May 26, 2026 at 8:00 AM

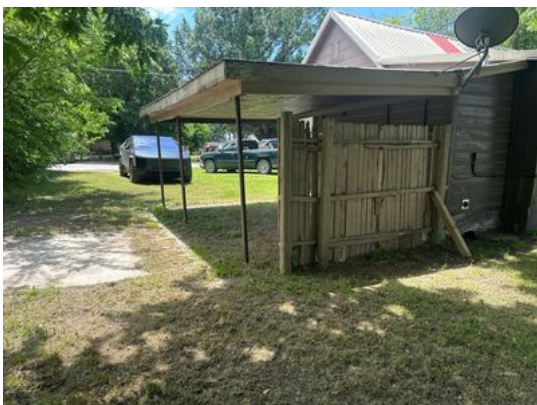
Northeast side of the site slopes away from structure.

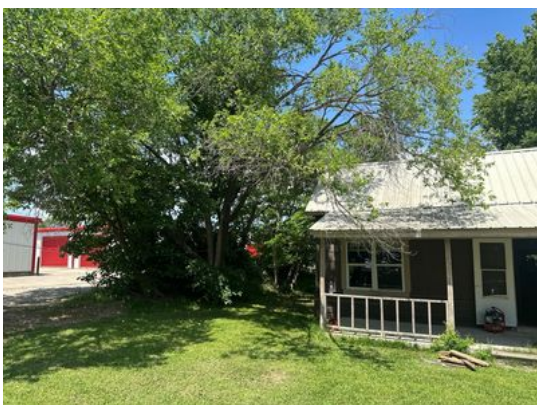
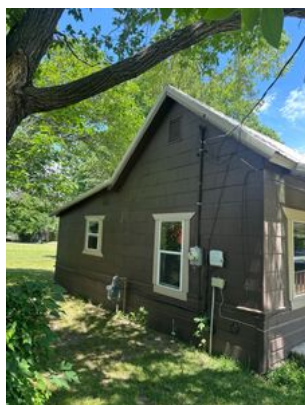
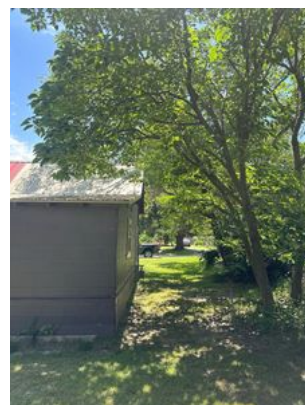
Generally Overgrown

Condition: Needs to be cut back and trimmed.

Recommend monitoring overgrowth around perimeter of home.

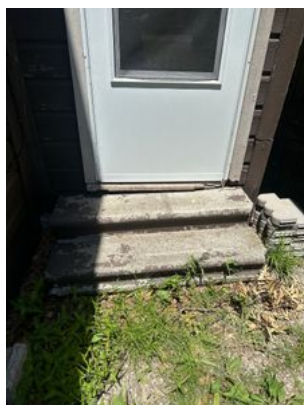
Further evaluation due to no landing. Recommend a landing outside exterior door.

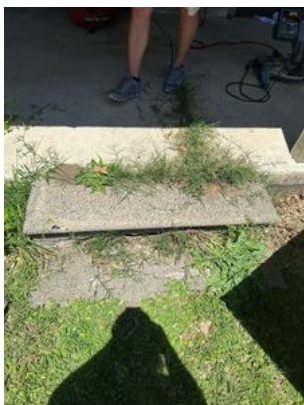
Steps entering the structure have observed overgrowth. This poses a trip hazard.

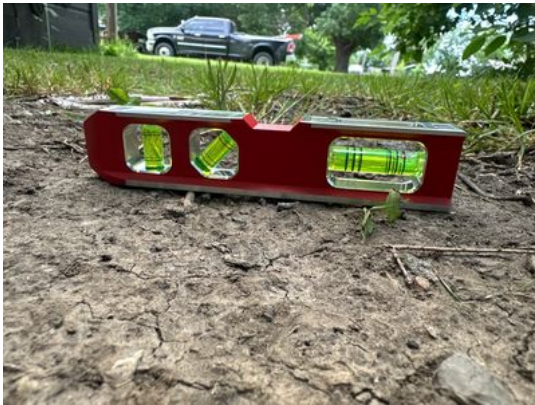
The grading slopes toward the home and will not shed water away from the home. This is a common cause of wet crawl spaces and leaking basements. Suggest adding fill dirt at low areas to prevent water from sitting next to home. Recommend further evaluation.

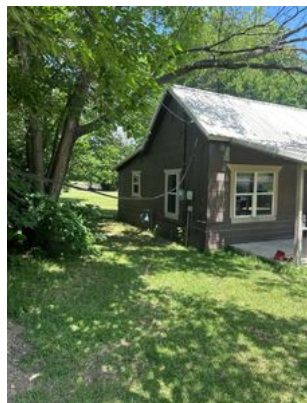
Utility line is tied to a tree limb and is too low to the ground. Potential safety hazard. Recommend further evaluation.

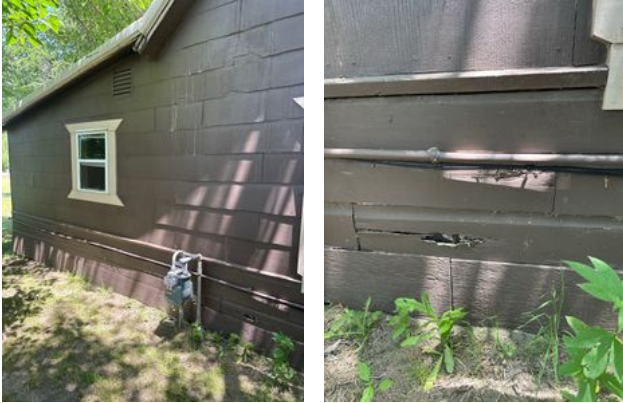
South side of home on the patio appears to have rotting.

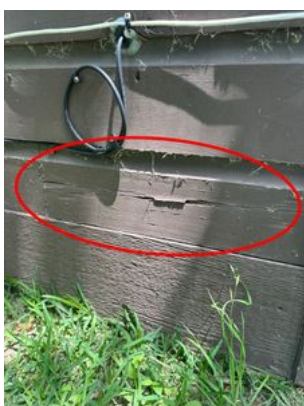
Rotting observed below service entrance on west side of structure. Recommend further evaluation or repair.

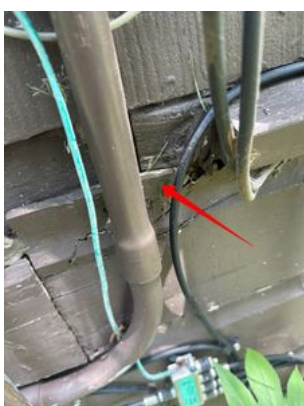
Observed rotting on west side of structure near gas meter. Recommend further evaluation or repair.

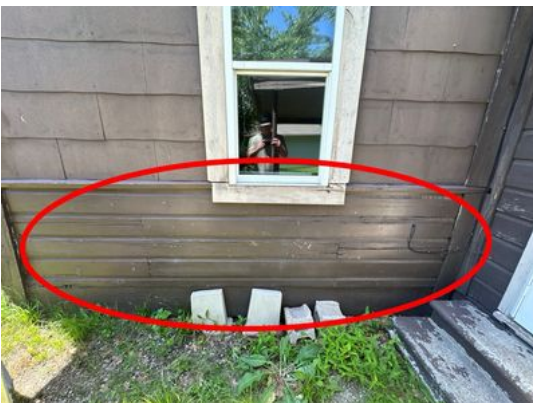
Splitting and rotting observed on east side of home near back door. Recommend further evaluation or replacement.

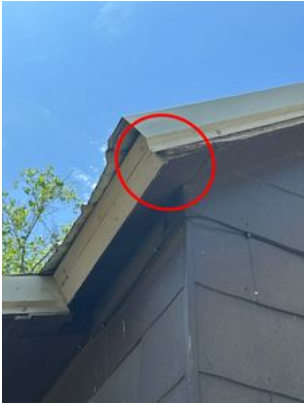
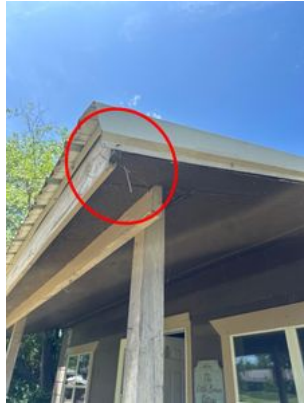
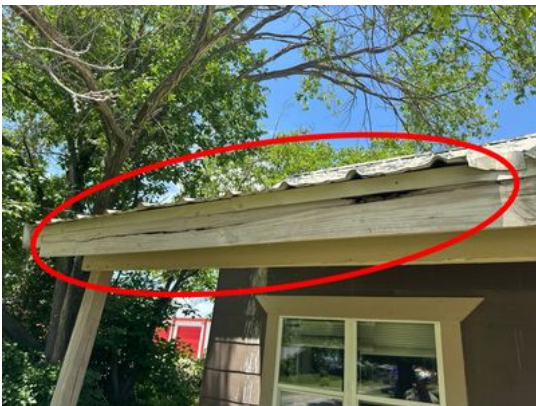
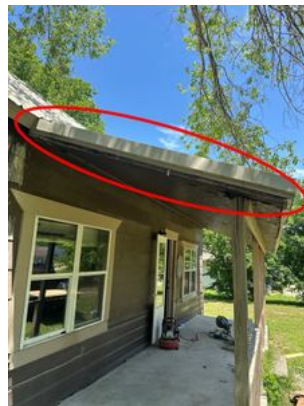
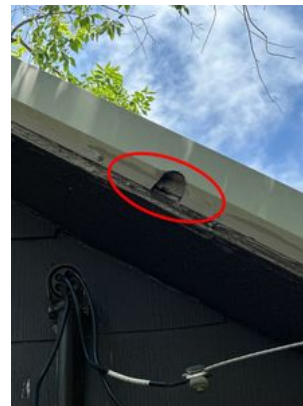
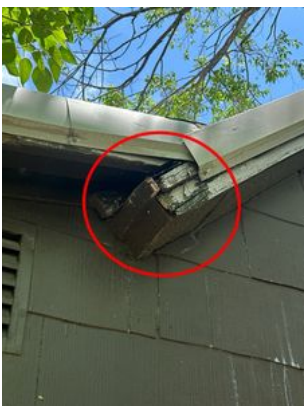
Observed multiple damaged exterior trim showing signs of deterioration. Recommend repair or replacement.

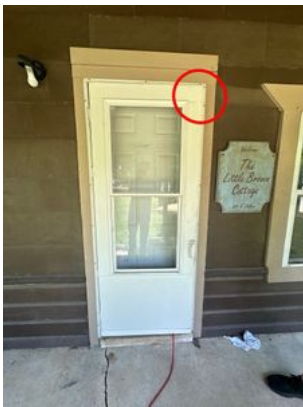
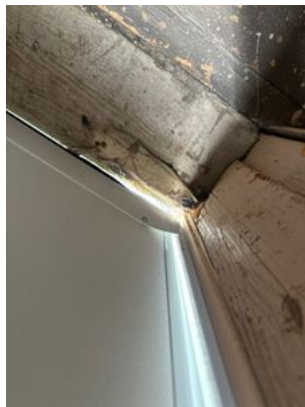
Main front entrance storm door drags. Storm doors are recommended to have door closers that control the doors swing.

Carport entrance door is unable to be opened without damaging the structure. Recommend repair due to safely being able to exit the property.

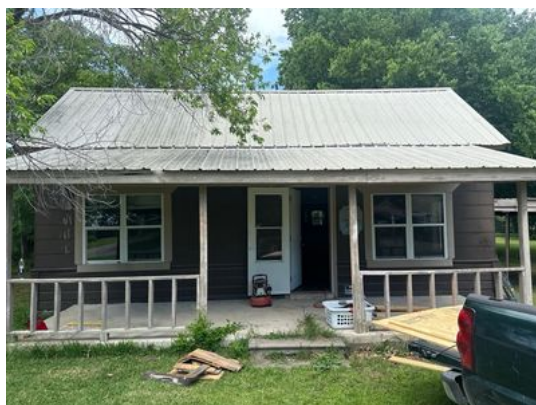
Railings appear to be too short and spacing between balusters are too wide. Recommend further evaluation.

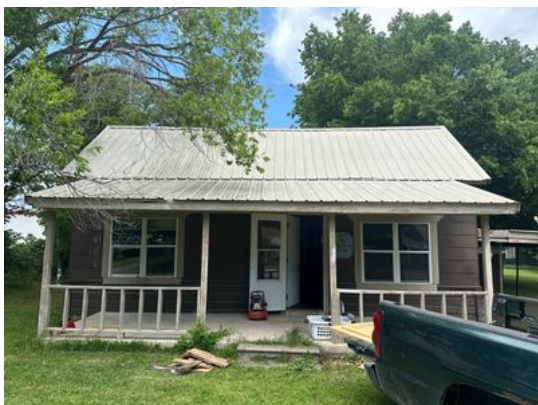
Limbs are encroaching on the roof of the structure. Recommend cutting back branches.

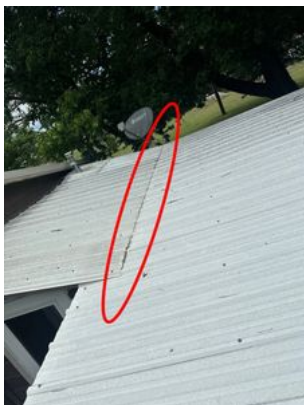
Carport Sealant is showing signs of deterioration. Recommend repair or replacement.

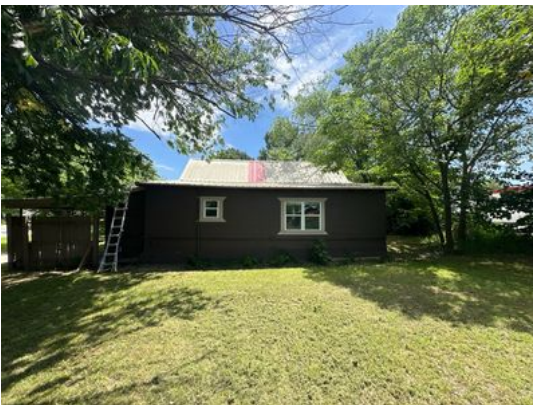
Observed “bowing” in the roof line on the North side of structure. Recommend monitoring the situation.

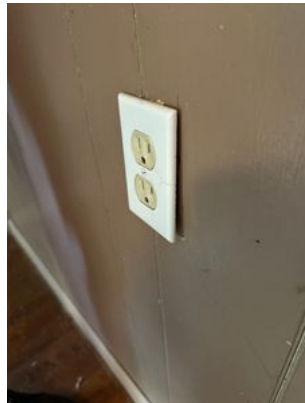
Observed open ground in all receptacles. Plug cover is loose in master bedroom.

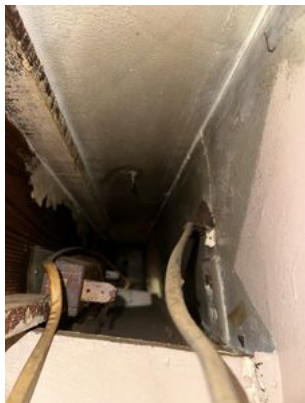
Wiring does not appear to be correct. Observed burnt plug inside kitchen cabinet. Recommend repair by a licensed electrician.

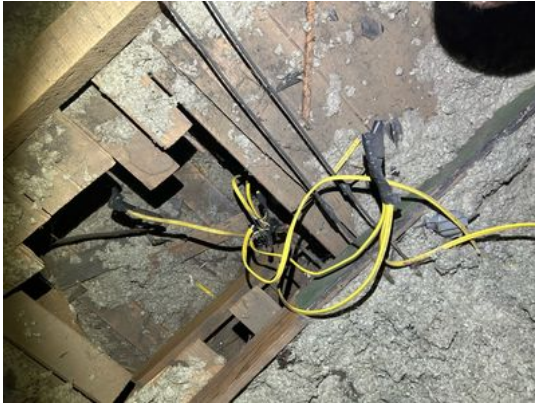
Knob and tube wiring and open splices were observed. Recommend repair by a licensed electrician.

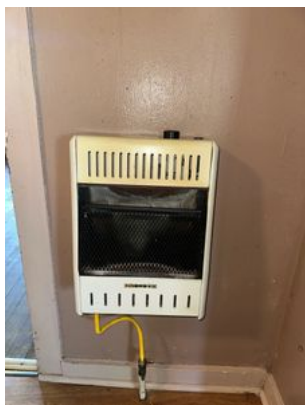
Gas is turned off on day of inspection.

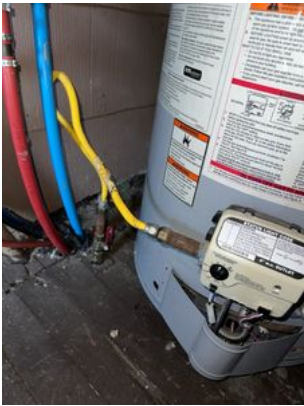
Disconnect appears outdated. Recommend evaluation by a licensed plumber.

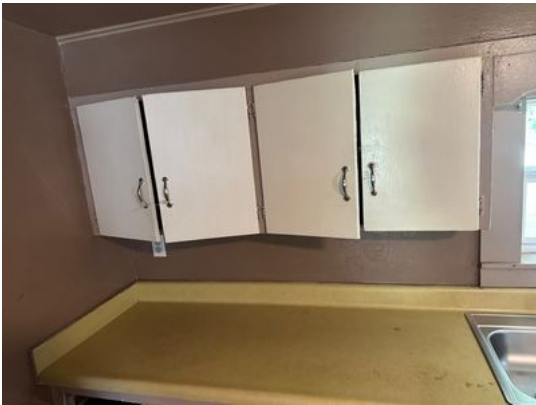
Several cabinets observed no remaining shut. Recommend repair.

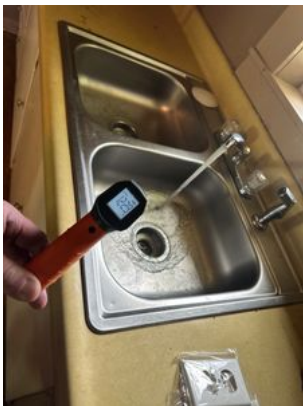
Kitchen sink water temperature is above the recommended temperature. Water temperature inside a house is recommended to not be above 120 degrees Fahrenheit to prevent scolding.

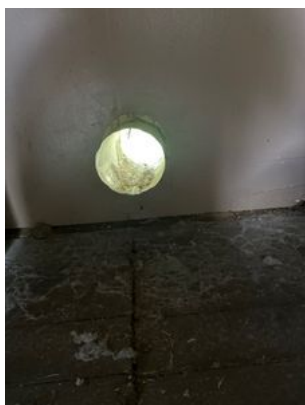
Recommend repair of dryer vent. Dryer vents are recommended to have a vent cap.

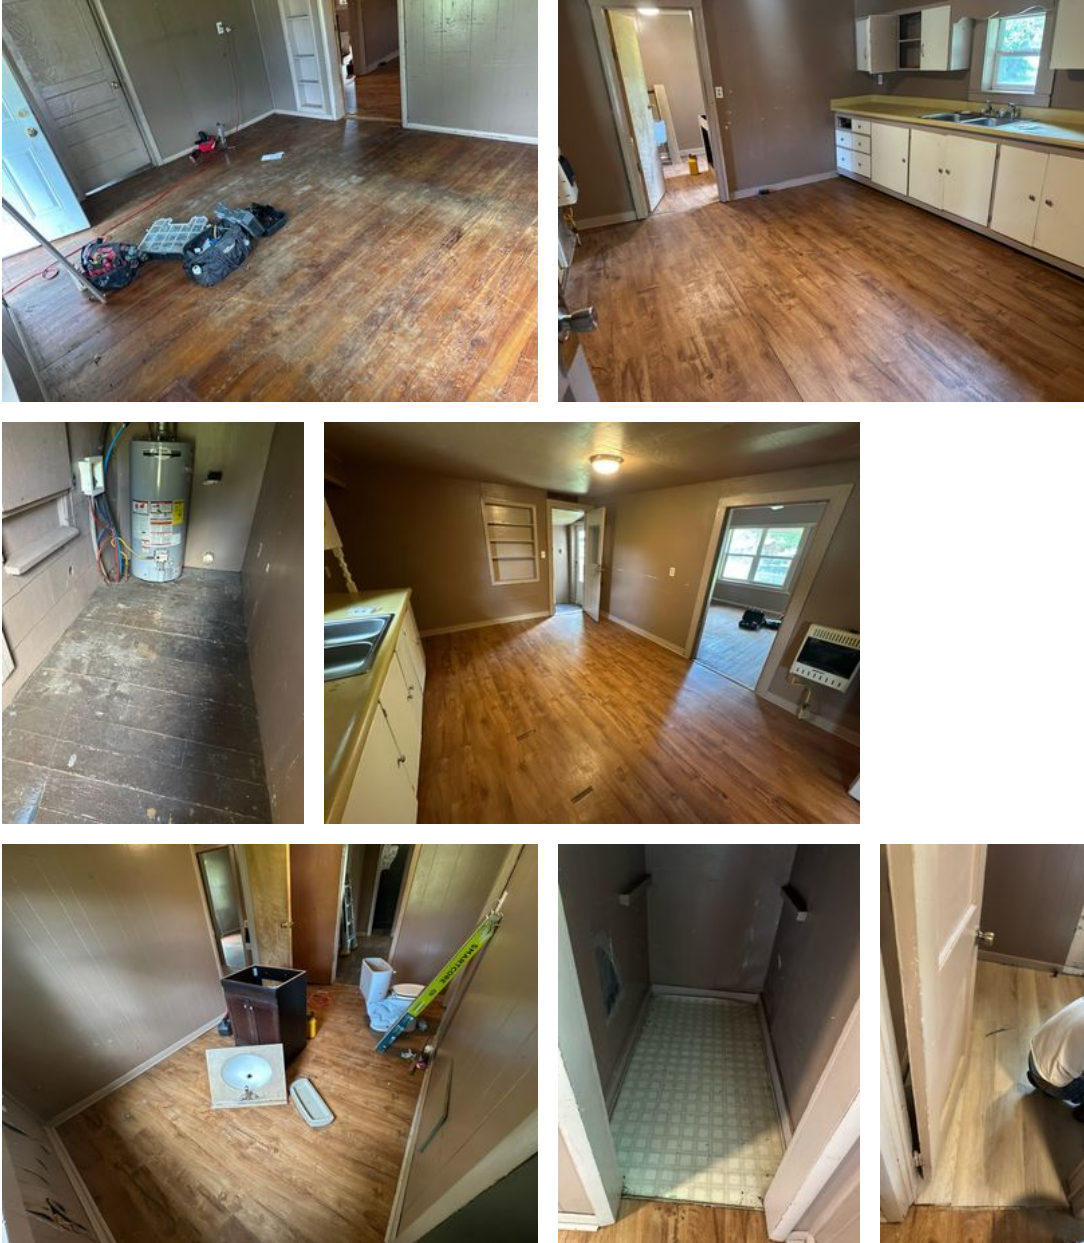
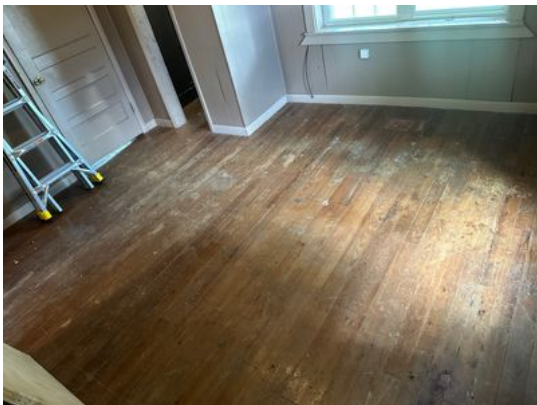
All floors in structured are not level and sagging. Floors throughout structure are showing signs of deterioration. Recommend repair or replacement.

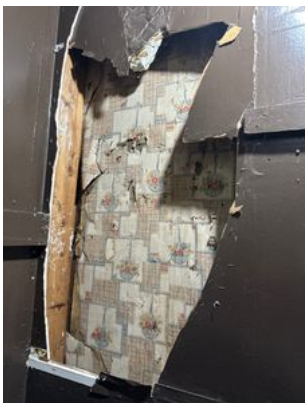
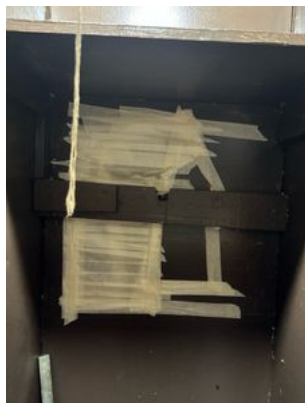
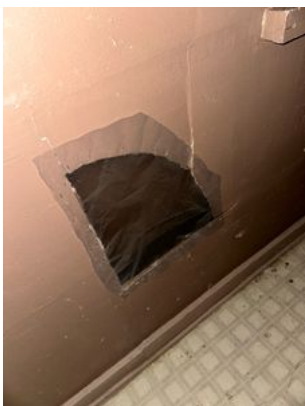
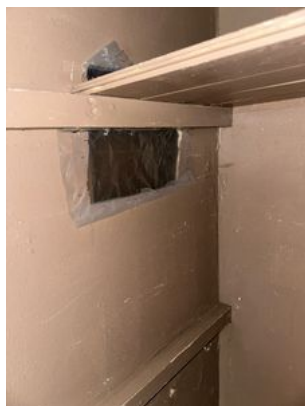
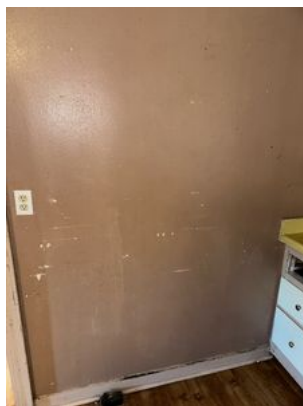
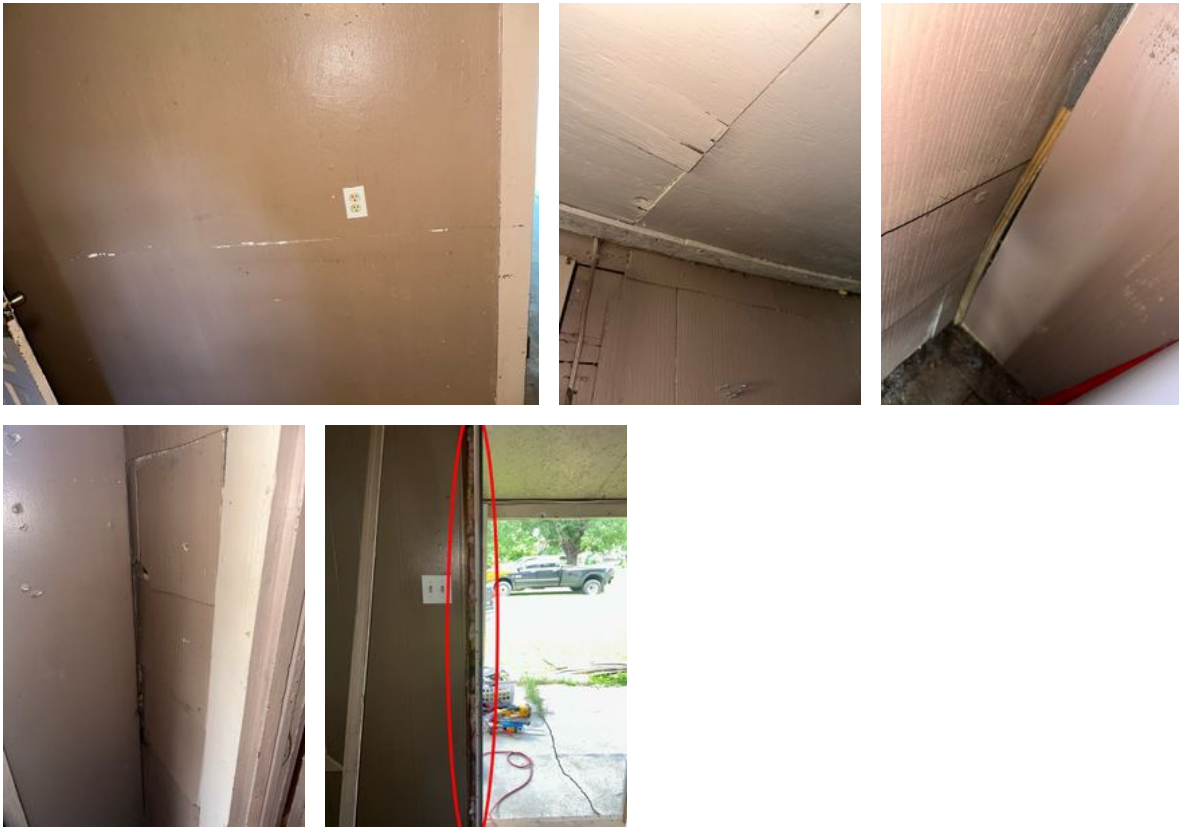
Multiple walls observed defects. Recommend repair or replacement.

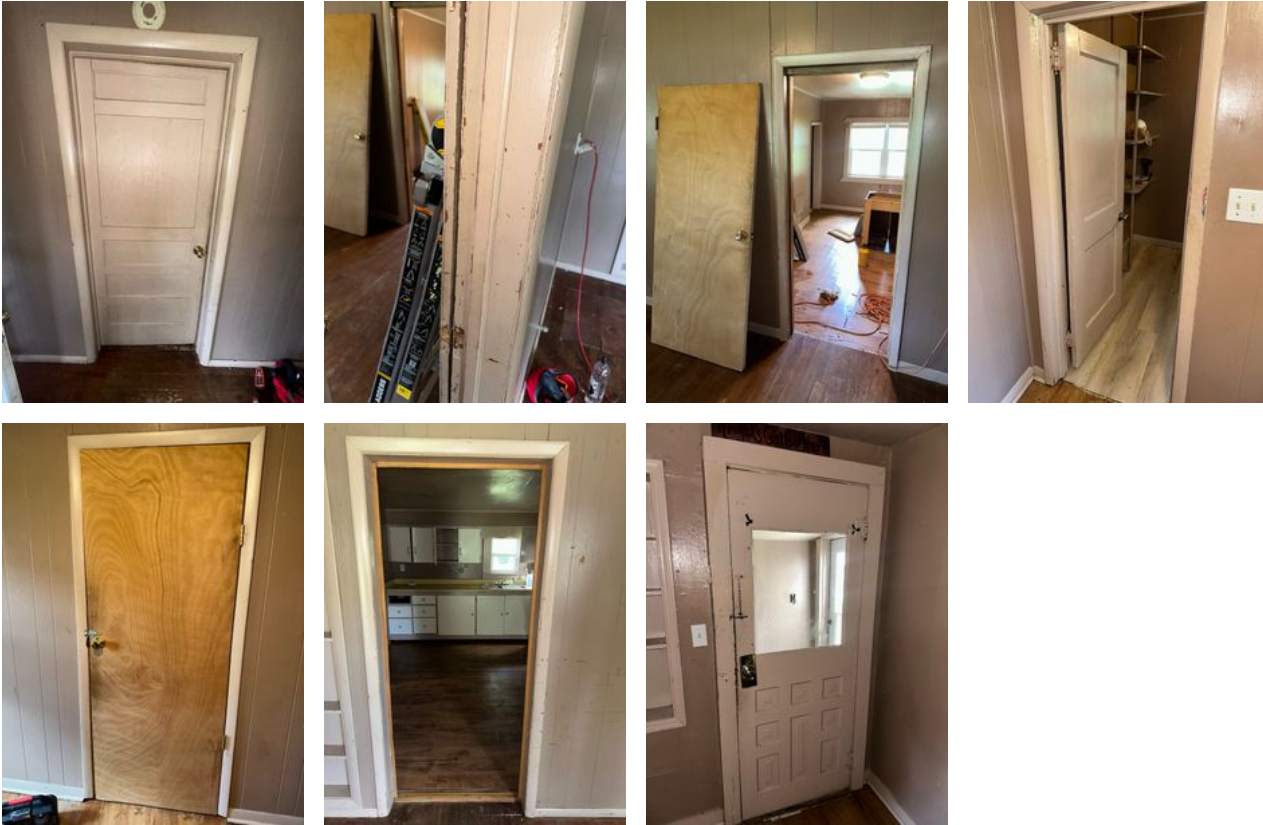
Kitchen door to laundry room will not latch and sags. Recommend repair.

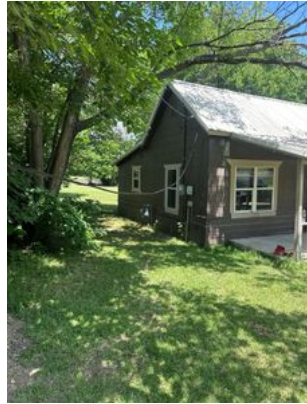
Utility line is tied to a tree limb and is too low to the ground. Potential safety hazard. Recommend further evaluation.

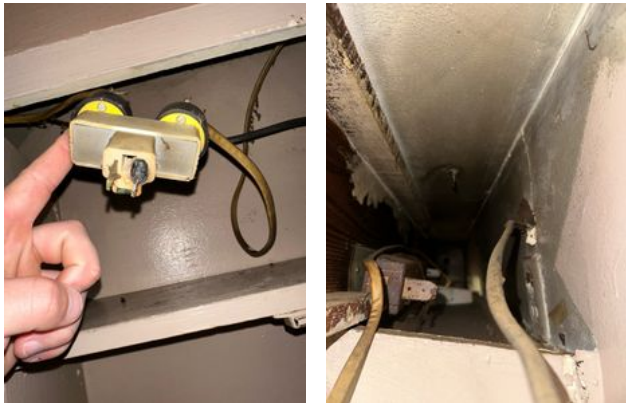
Wiring does not appear to be correct. Observed burnt plug inside kitchen cabinet. Recommend repair by a licensed electrician.

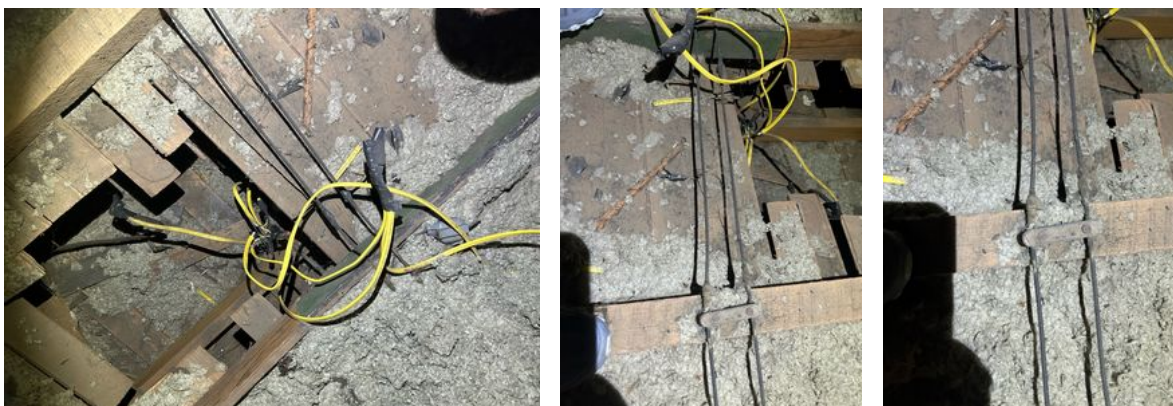
Knob and tube wiring and open splices were observed. Recommend repair by a licensed electrician.

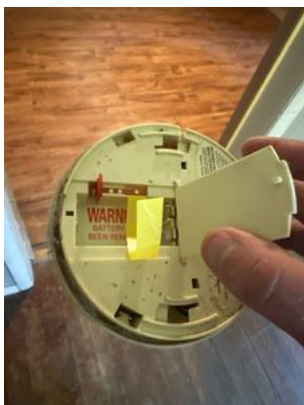
No batteries in smoke detector.

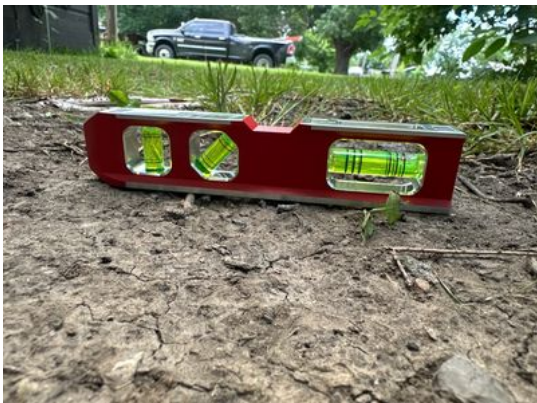
The grading slopes toward the home and will not shed water away from the home. This is a common cause of wet crawl spaces and leaking basements. Suggest adding fill dirt at low areas to prevent water from sitting next to home. Recommend further evaluation.

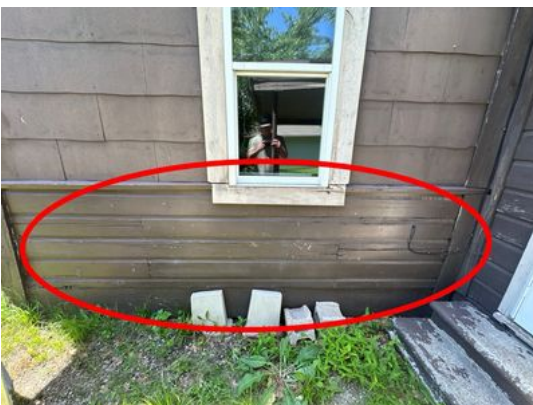
Splitting and rotting observed on east side of home near back door. Recommend further evaluation or replacement.

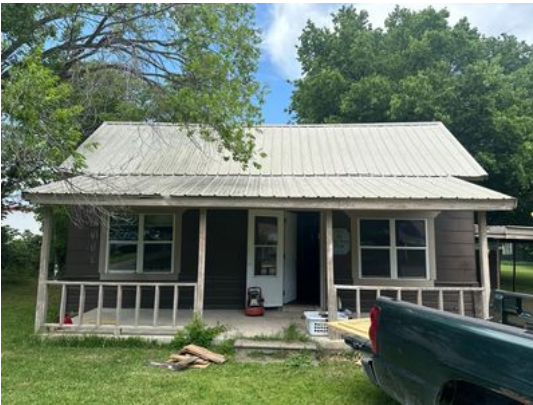
Limbs are encroaching on the roof of the structure. Recommend cutting back branches.

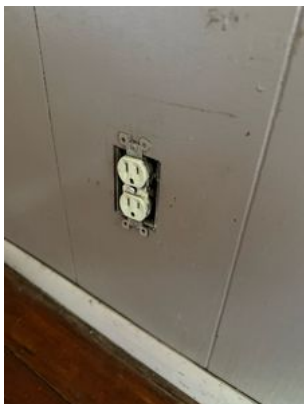
Missing cover plate in living room.

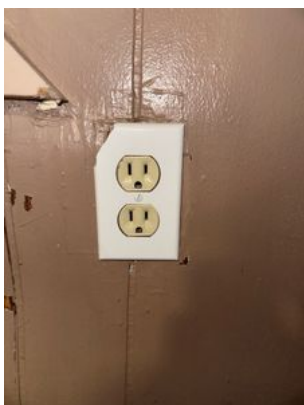
Broken receptacle cover in the middle bedroom north side of house.

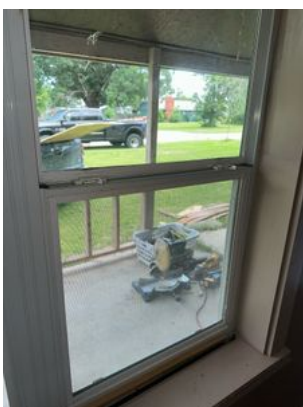
Southeast front window will not remain open. Recommend repair.

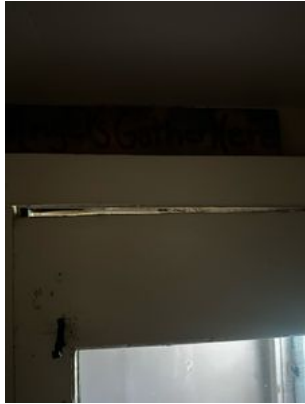
Kitchen door to laundry room will not latch and sags. Recommend repair.
