First Due Home Inspections, LLC  
(580) 369-1105  
FirstDueHomeInspectors.com  
FDHInspections@gmail.com

## Home Inspection Report

123 Example St  
Oklahoma City, OK 73130

Inspected By: Payton Webber

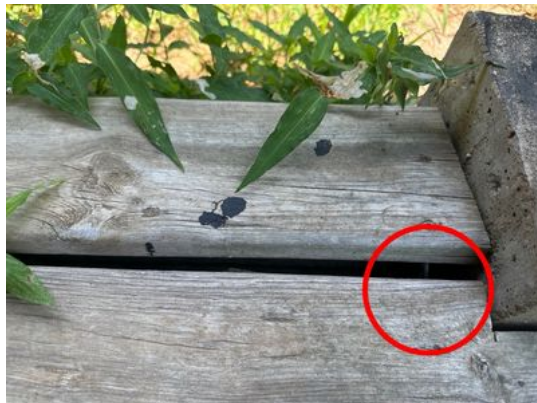
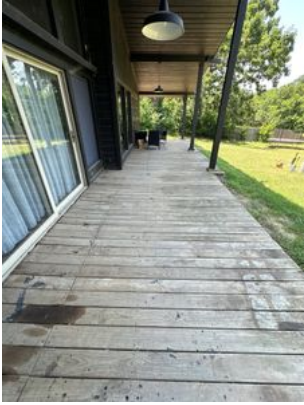
The exterior patio/deck surface is bowed/sagging toward the center, and multiple deck boards are loose. These conditions may indicate structural movement or deterioration and present a potential trip hazard. Recommend evaluation and repair by a qualified contractor to restore proper support and secure all loose decking components.

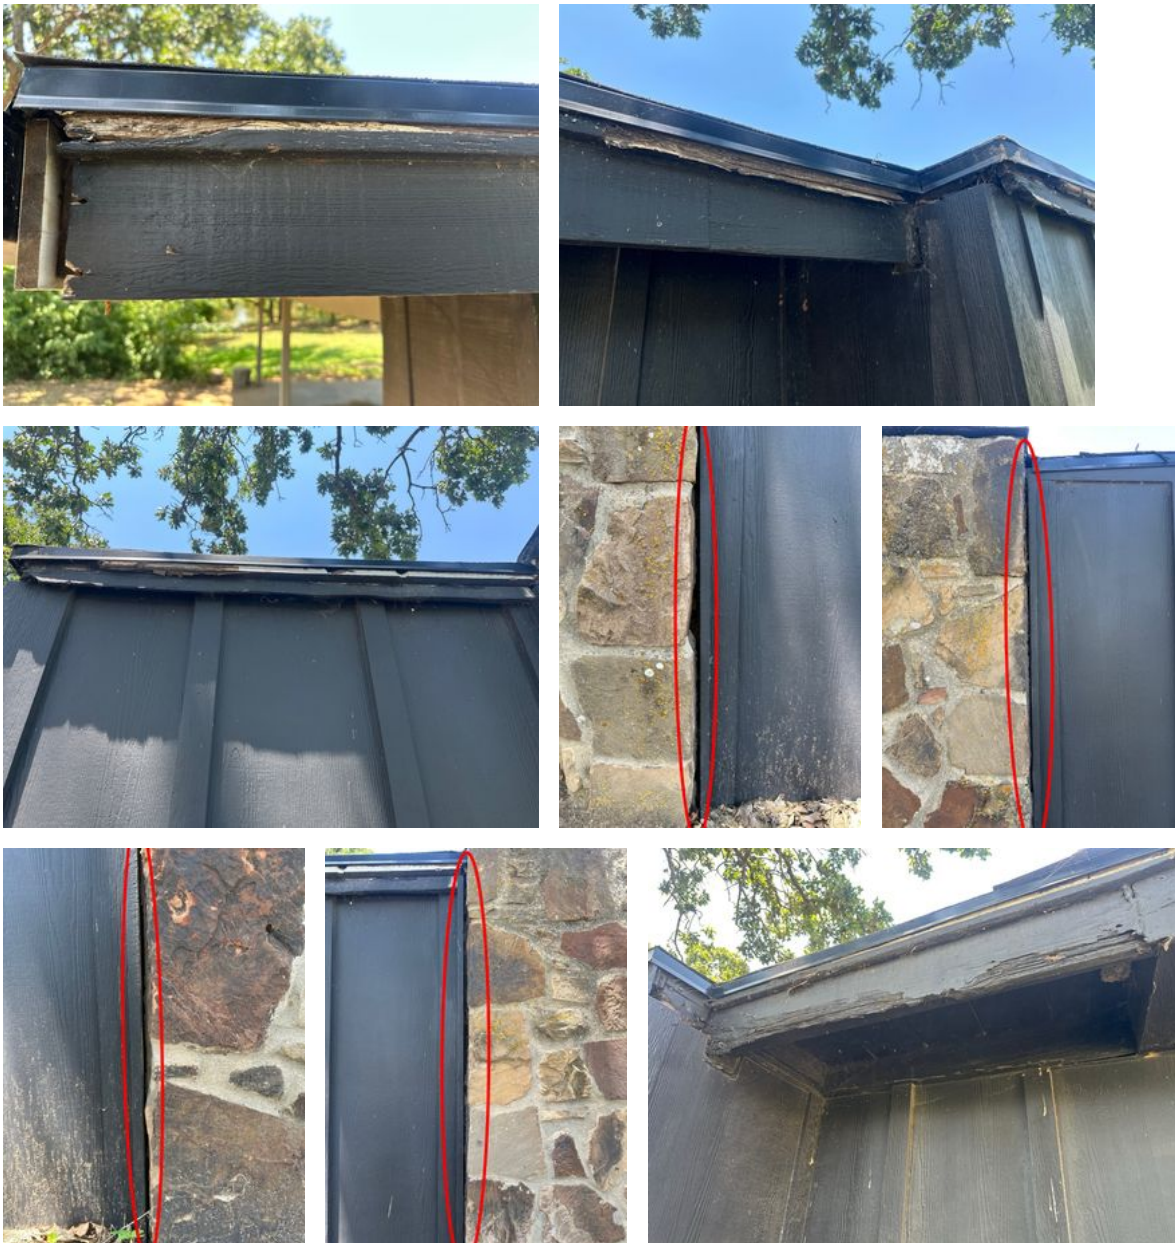
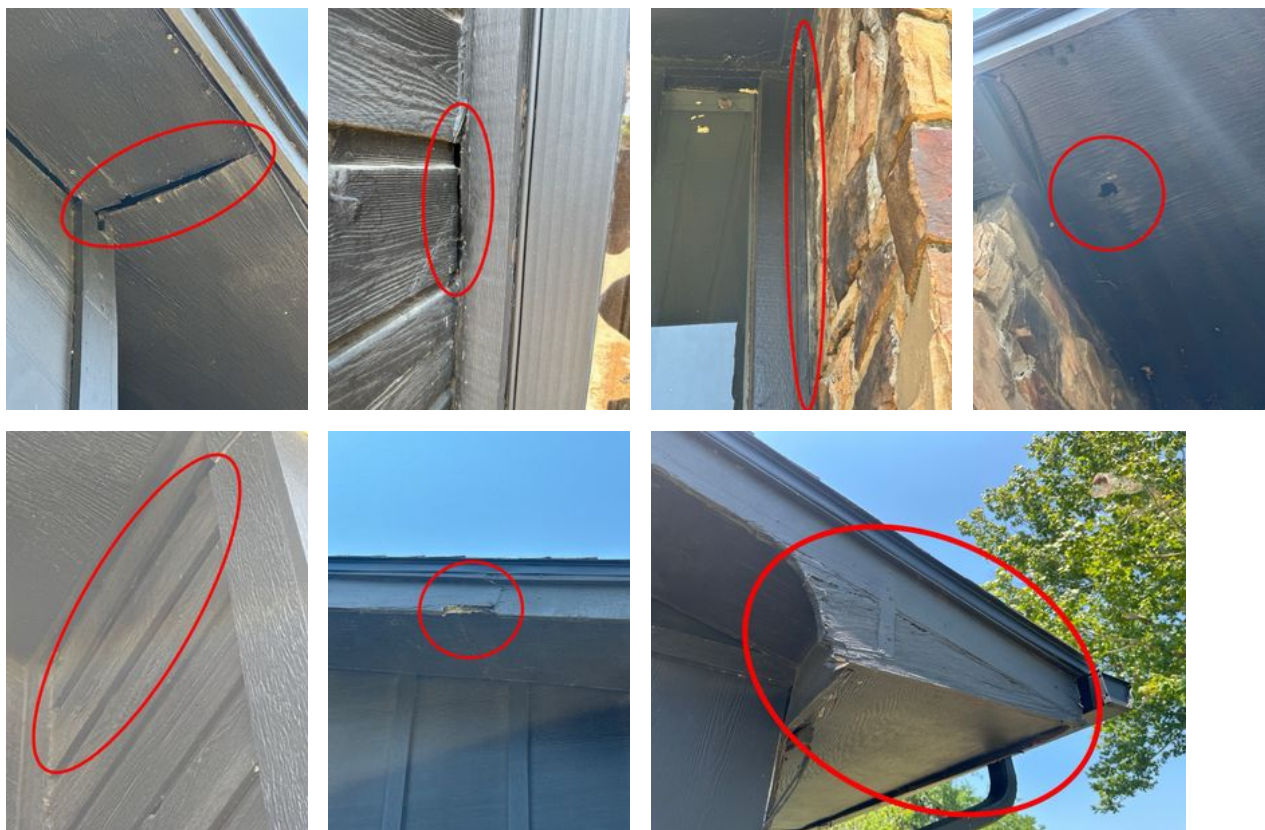
The exterior wall covering, trim, and associated exterior finish components exhibit areas of deterioration, damage, and/or improper installation. These conditions may allow moisture intrusion, accelerate material deterioration, and reduce the ability of the exterior envelope to protect the structure. Recommend evaluation and repair or replacement of all affected components by a qualified contractor. All repairs should be properly sealed, flashed where applicable, and finished to help prevent future moisture intrusion and deterioration. These problems pictured are on the South facing side of the house.

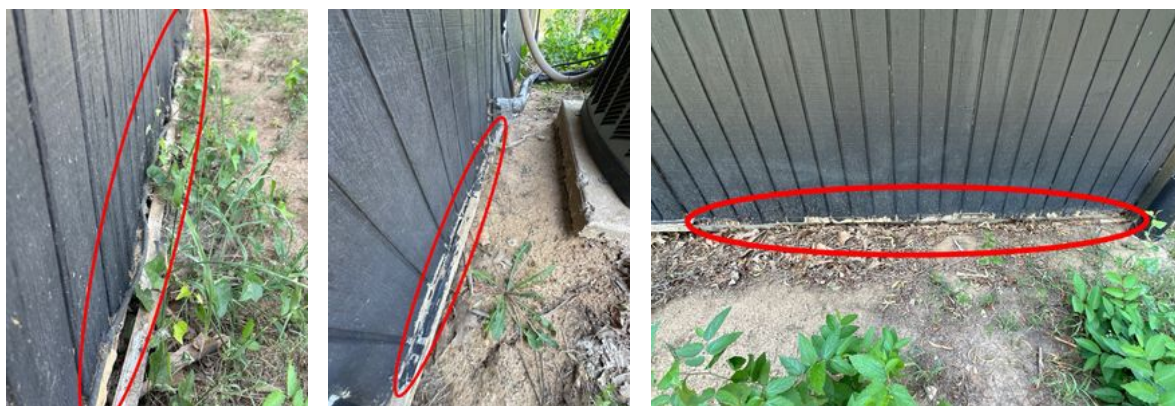
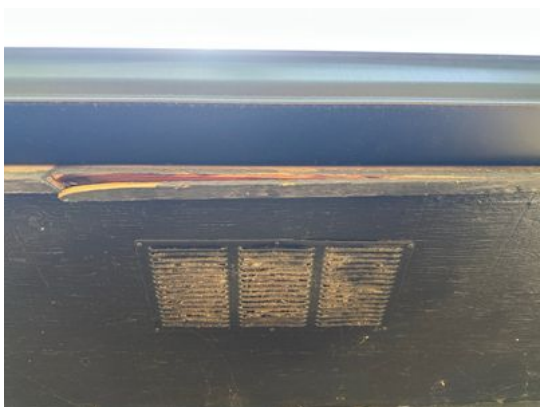
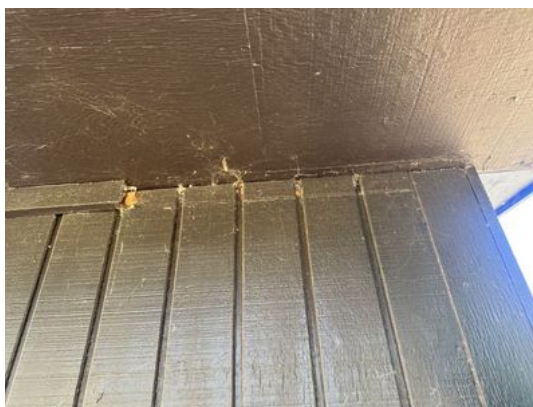
The exterior wall covering, trim, and associated exterior finish components exhibit areas of deterioration, damage, and/or improper installation. These conditions may allow moisture intrusion, accelerate material deterioration, and reduce the ability of the exterior envelope to protect the structure. Recommend evaluation and repair or replacement of all affected components by a qualified contractor. All repairs should be properly sealed, flashed where applicable, and finished to help prevent future moisture intrusion and deterioration. The problems pictured are located on the East side of the structure.

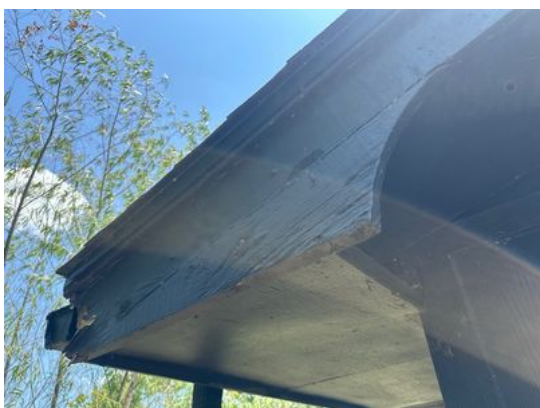
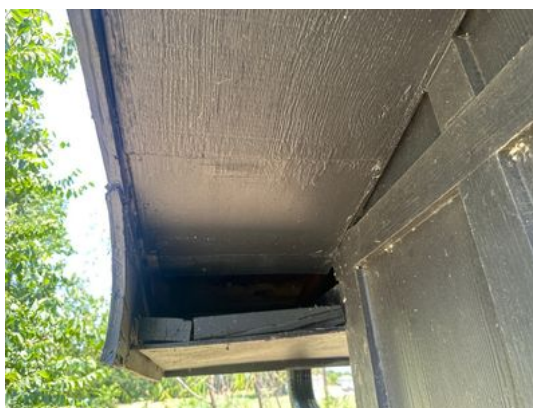
Wood trim/fascia and soffit components at the roof edges and wall intersections on the North East corner exhibited signs of deterioration, including rot, openings, and gaps. These deficiencies can allow moisture intrusion and provide entry points for insects, birds, and other pests while contributing to further deterioration of the surrounding materials. Recommend repair or replacement of the damaged components, sealing of all openings, and evaluation of adjacent materials for concealed moisture damage by a qualified contractor.

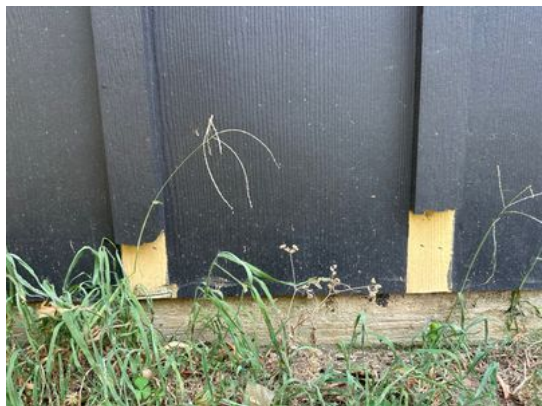
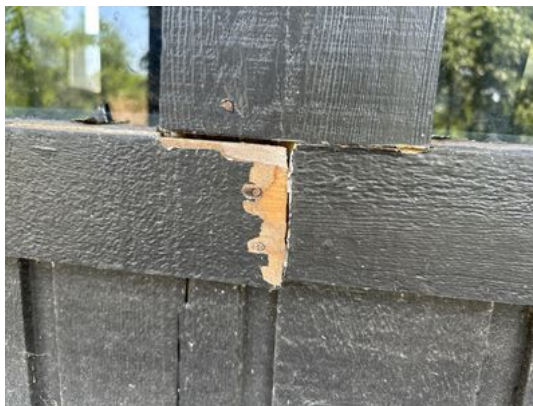
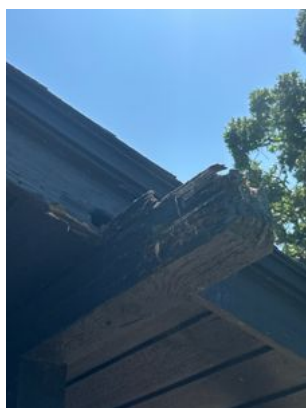
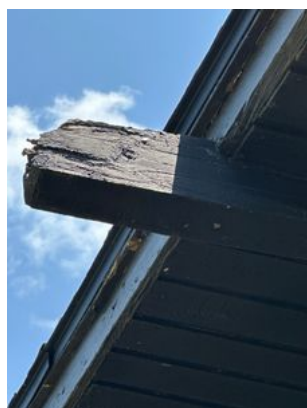
The exterior wall covering, trim, and associated exterior finish components exhibit areas of deterioration, damage, and/or improper installation. These conditions may allow moisture intrusion, accelerate material deterioration, and reduce the

ability of the exterior envelope to protect the structure. Recommend evaluation and repair or replacement of all affected components by a qualified contractor. All repairs should be properly sealed, flashed where applicable, and finished to help prevent future moisture intrusion and deterioration. These problems pictured are on the North facing side of the house.

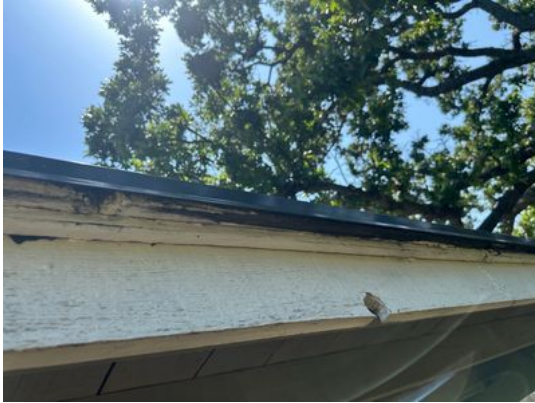
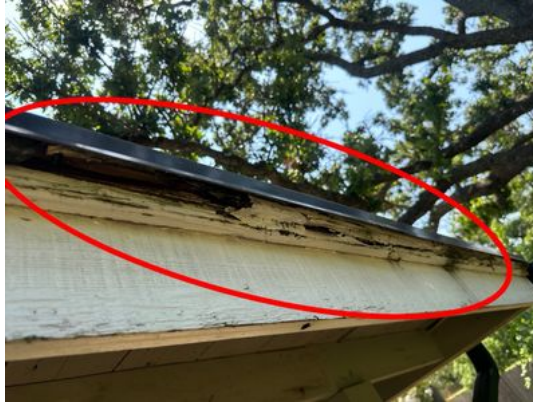
Northwest corner of carport trim/fascia and soffit components are showing signs of rot and deterioration. Recommend repair.

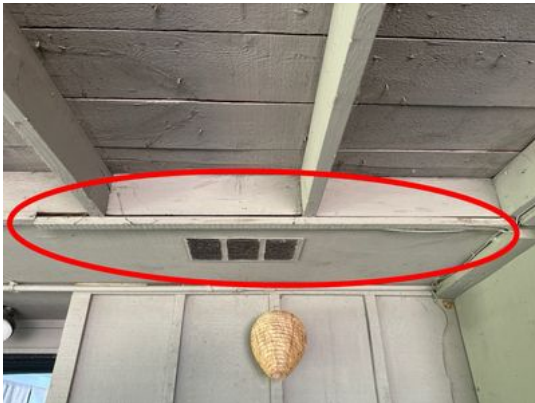
Trim is beginning to show signs of deterioration and failure. Recommend repair or replacement.

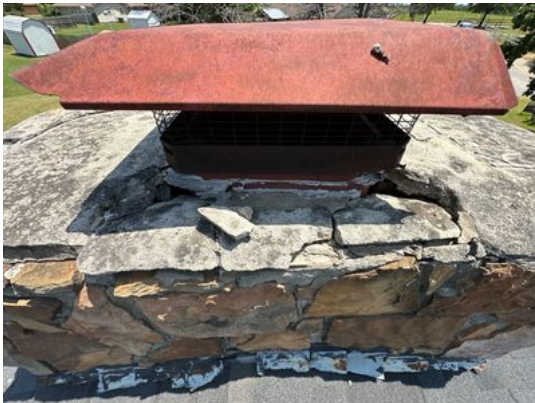
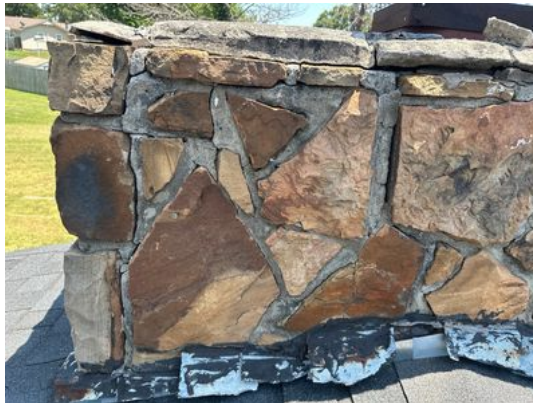
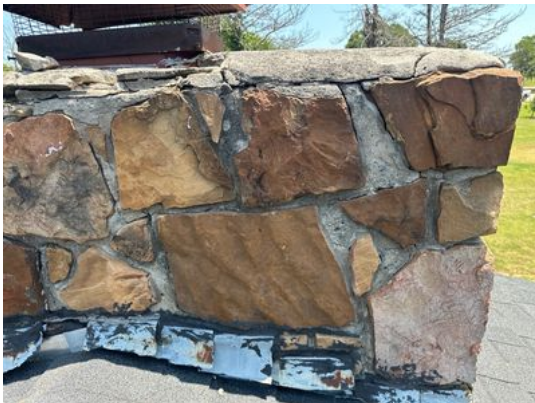
The chimney crown exhibits cracking and deterioration. The damaged crown may allow water intrusion into the chimney structure, leading to further deterioration. Recommend evaluation and repair by a qualified chimney contractor.

Mortar joints within the chimney exhibit deterioration and cracking. Damaged mortar can permit moisture intrusion and contribute to continued deterioration. Recommend tuck-pointing or repairs by a qualified masonry contractor.

Flashing at the chimney base exhibits corrosion and signs of previous repairs. Deteriorated flashing may permit water intrusion. Recommend repair or replacement by a qualified roofing contractor.

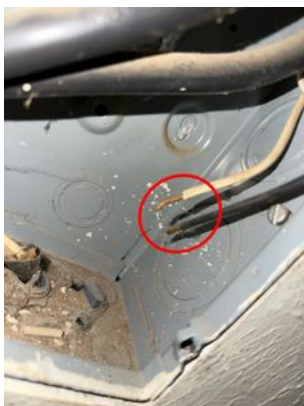
Loose/unterminated conductors were observed within the electrical panel enclosure. Unsecured conductors may present a shock hazard if energized and can indicate incomplete or abandoned wiring. Recommend evaluation by a qualified licensed electrician to determine whether the conductors are energized and to properly terminate, remove, or safely cap them as needed.

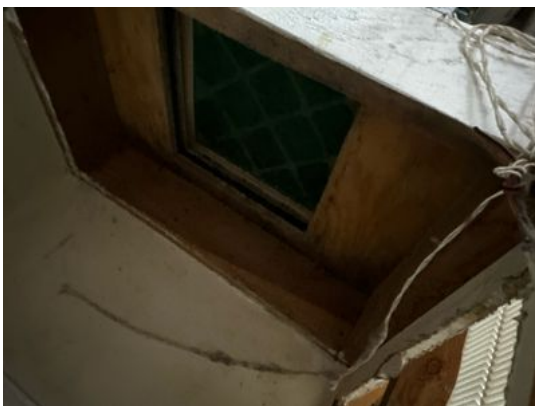
The supply plenum/ductwork was not connected to the air handler at the time of the inspection. As a result, conditioned air is not being properly distributed throughout the home. This condition can significantly impact the performance and efficiency of the HVAC system. Recommend evaluation and repair by a qualified HVAC contractor.

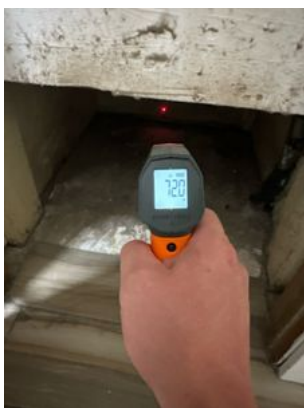
The supply plenum/ductwork was not connected to the air handler at the time of the inspection. As a result, conditioned air is not being properly distributed throughout the home. This condition can significantly impact the performance and efficiency of the HVAC system. Recommend evaluation and repair by a qualified HVAC contractor.

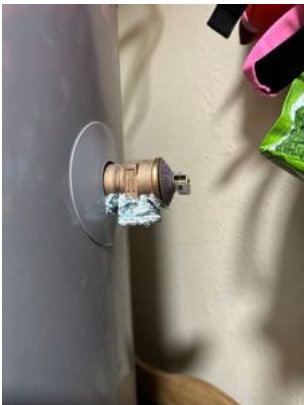
The water heater is missing the temperature and pressure (T&P) relief valve discharge pipe (blow-off tube). This pipe is a critical safety component designed to safely direct hot water and steam away from occupants if the relief valve opens. Recommend installation of a properly sized and terminated discharge pipe by a qualified plumber.

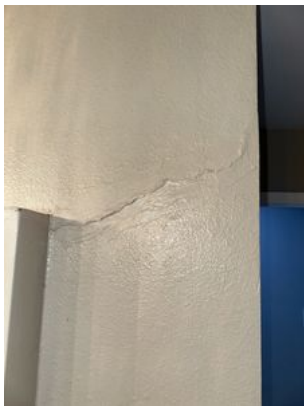
Minor crack observed in master bath. Recommend monitoring.

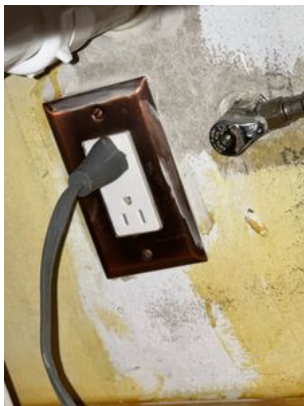
No GFCI protection was present for the required kitchen countertop receptacle(s) at the time of the inspection. GFCI protection is an important safety feature designed to reduce the risk of electrical shock in areas where water is commonly present. Recommend installation of GFCI-protected receptacles or circuit protection by a qualified electrician.

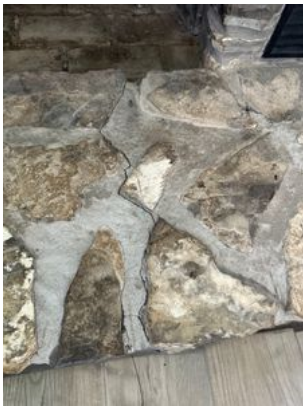
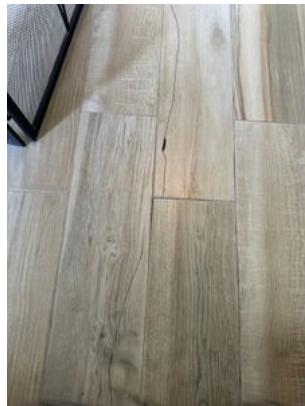
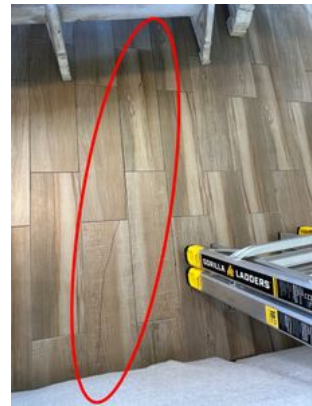
A crack was observed in the tile flooring extending a significant distance across the floor. The crack remained relatively consistent in width with no significant vertical displacement observed at the time of the inspection. The cause of the cracking could not be determined during this visual inspection. Recommend monitoring for additional movement. If the crack widens, develops vertical displacement, or additional signs of movement are observed, further evaluation by a qualified foundation or structural professional is recommended.

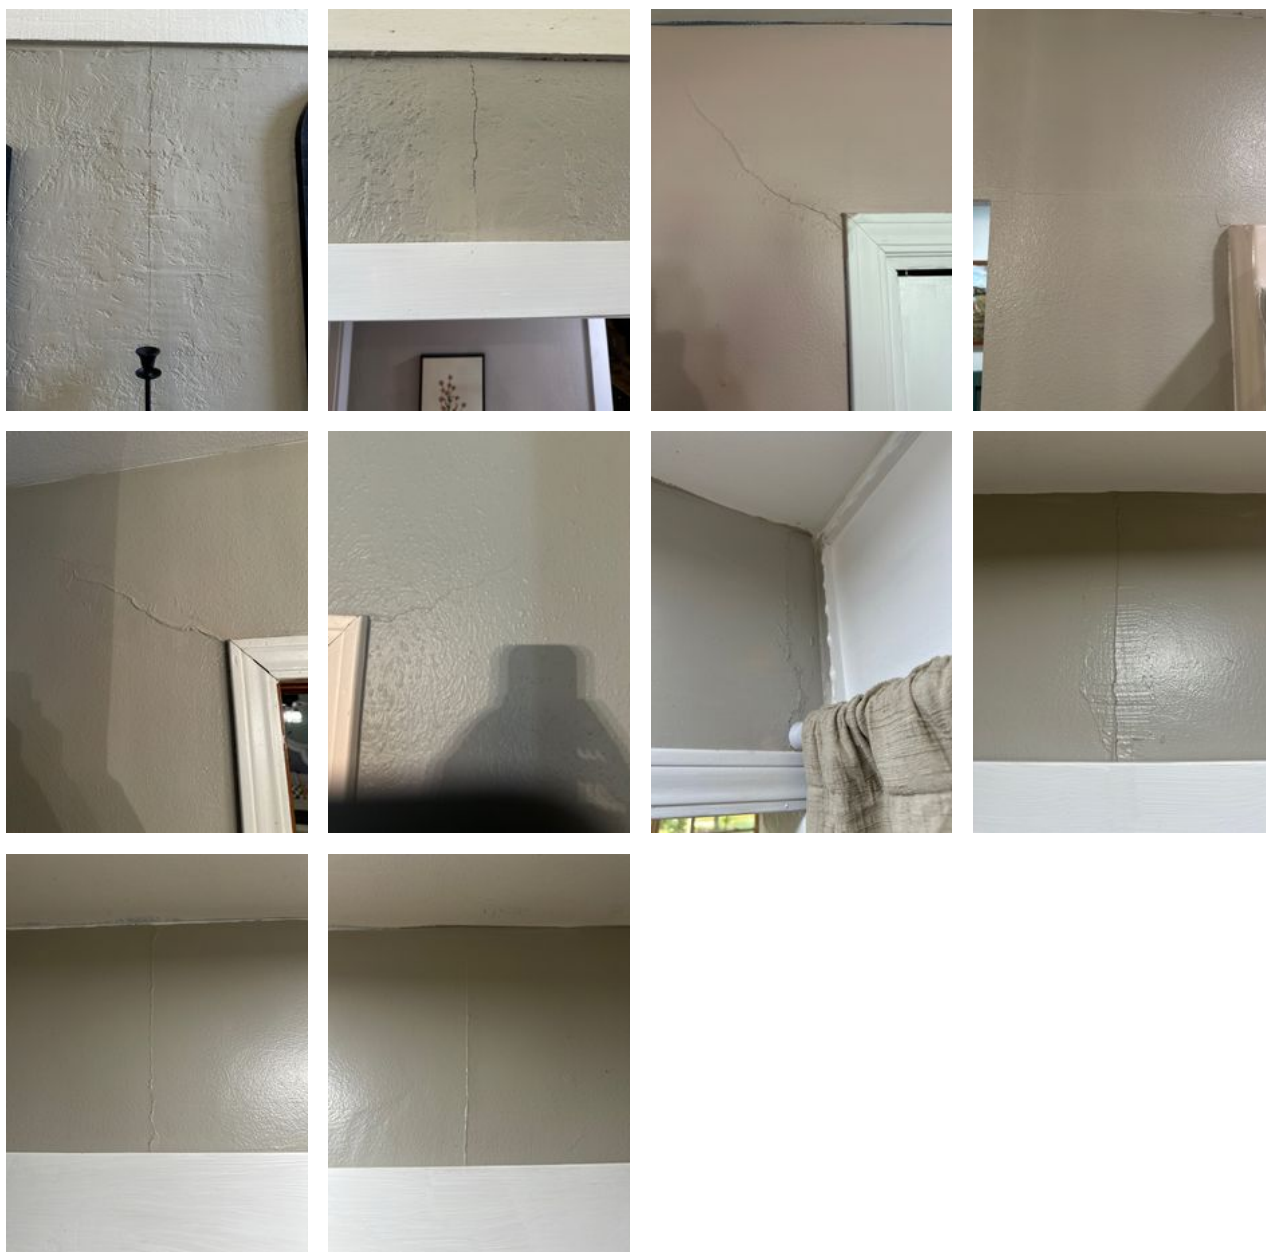
Minor settlement-related cracks were observed. These types of cracks are common as a home ages and, at the time of the inspection, appeared consistent with normal settlement. No significant indications of structural movement were observed in these areas. Recommend monitoring the cracks for changes in width, length, or displacement. If movement is observed or the cracks worsen over time, further evaluation by a qualified structural professional is recommended.

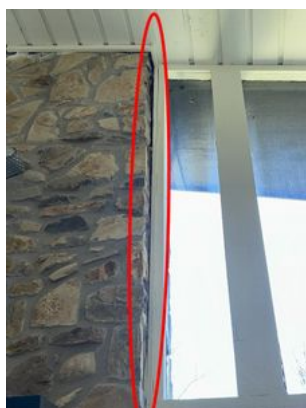
Separation was observed between the stone fireplace surround and the adjacent wood trim/finish. This condition is likely the result of normal differential movement between dissimilar building materials but may allow air and moisture intrusion and detracts from the finished appearance. Recommend sealing or repairing the separation as needed and monitoring for any signs of continued movement or widening. If significant movement is observed, further evaluation by a qualified contractor is recommended.

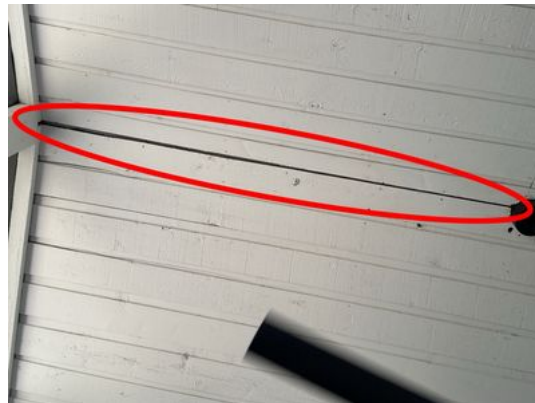
A linear separation was observed along a ceiling panel joint in the vaulted living room ceiling. The separation appeared straight and generally uniform in width, with no significant displacement noted at the time of the inspection. This condition is consistent with typical movement that can occur from normal settlement and/or seasonal expansion and contraction. Recommend monitoring for any increase in width, displacement, or additional cracking. If significant changes are observed, further evaluation by a qualified contractor is recommended.

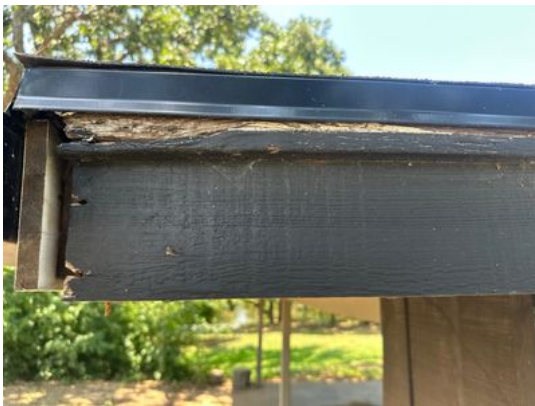
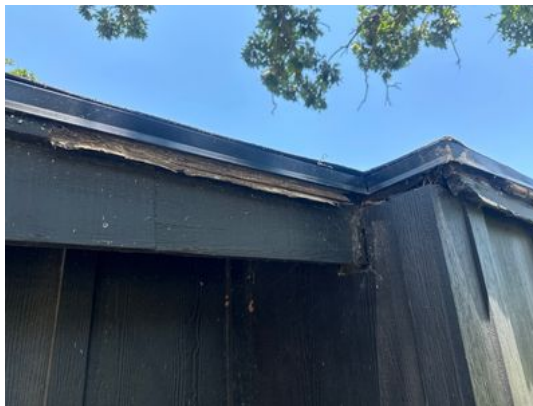
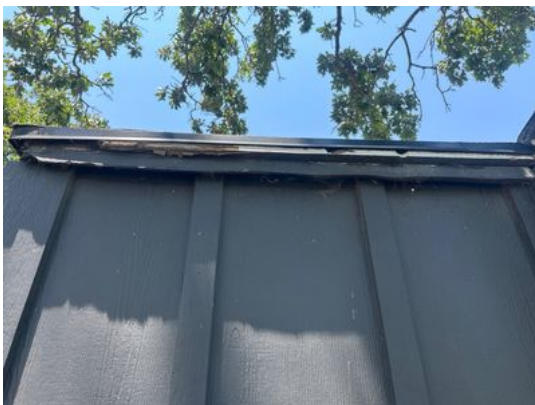
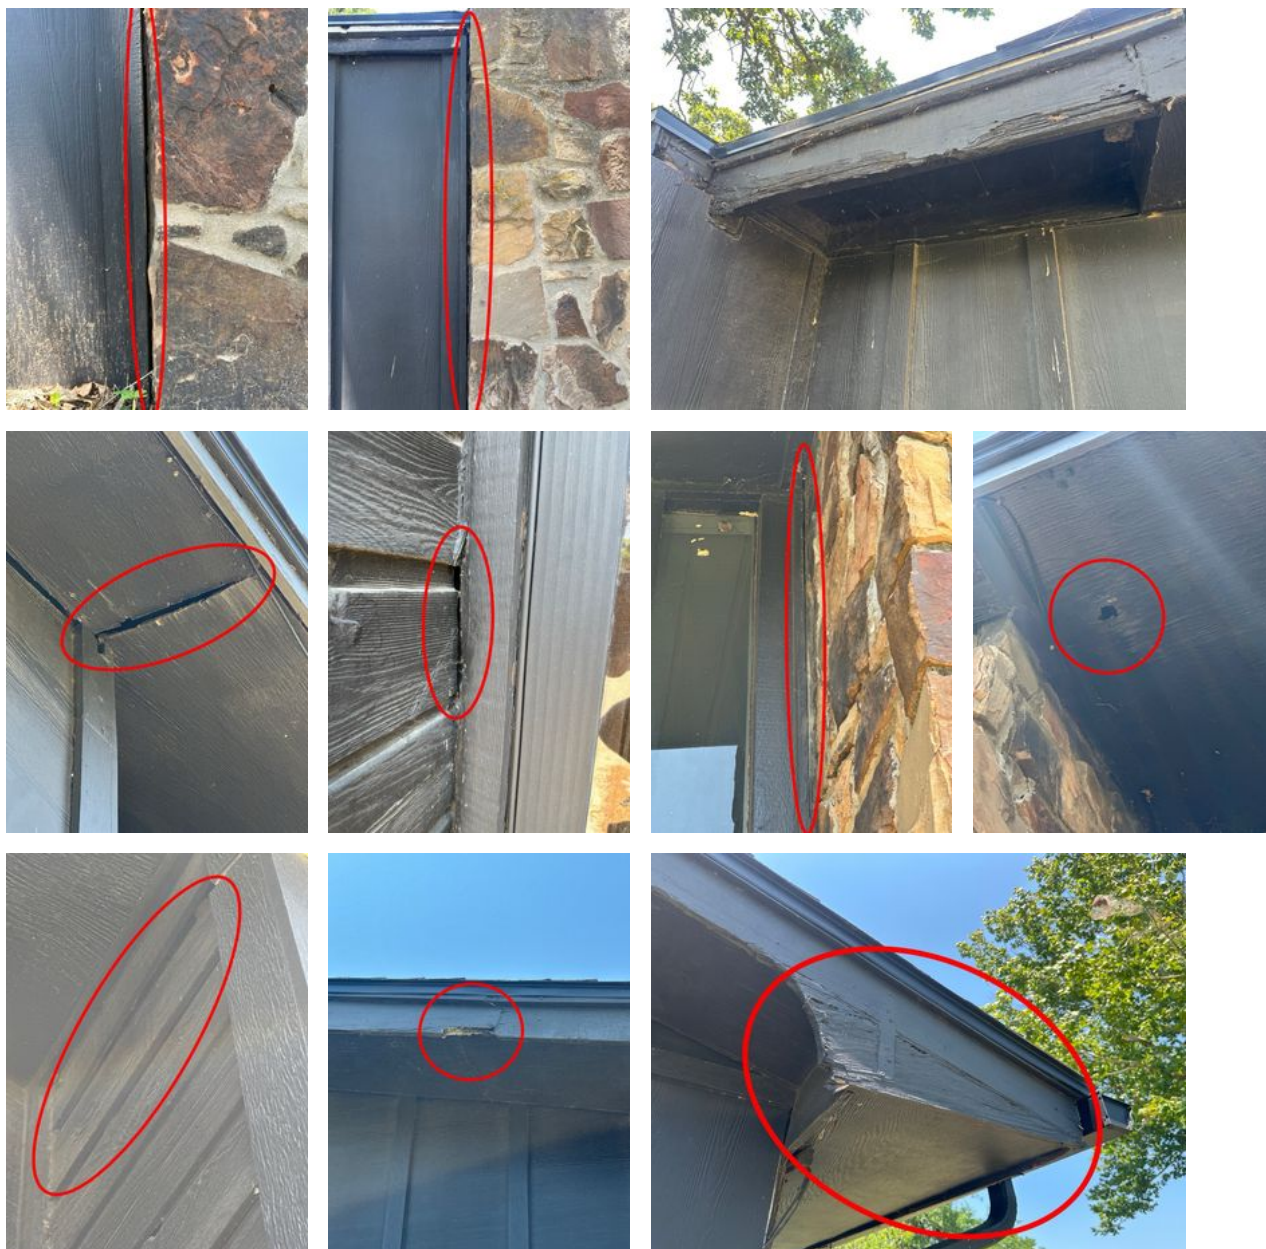
#### Exterior: Exterior Covering

The exterior wall covering, trim, and associated exterior finish components exhibit areas of deterioration, damage, and/or improper installation. These conditions may allow moisture intrusion, accelerate material deterioration, and reduce the ability of the exterior envelope to protect the structure. Recommend evaluation and repair or replacement of all affected components by a qualified contractor. All repairs should be properly sealed, flashed where applicable, and finished to help prevent future moisture intrusion and deterioration. These problems pictured are on the South facing side of the house.

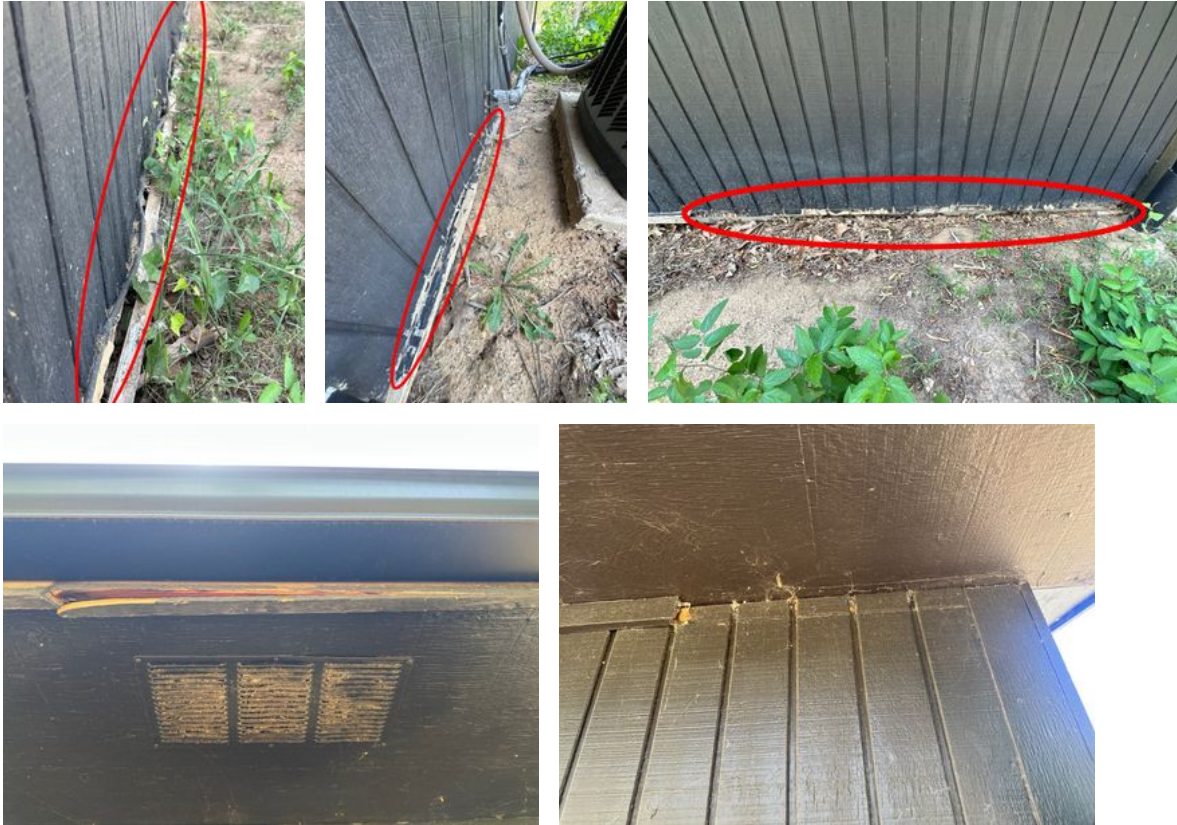
#### Exterior: Exterior Covering

The exterior wall covering, trim, and associated exterior finish components exhibit areas of deterioration, damage, and/or improper installation. These conditions may allow moisture intrusion, accelerate material deterioration, and reduce the

ability of the exterior envelope to protect the structure. Recommend evaluation and repair or replacement of all affected components by a qualified contractor. All repairs should be properly sealed, flashed where applicable, and finished to help prevent future moisture intrusion and deterioration. The problems pictured are located on the East side of the structure.

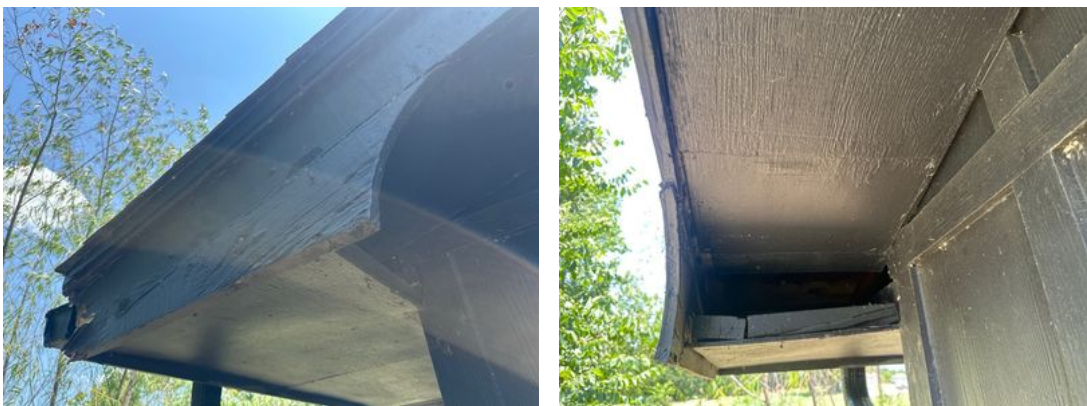
#### Exterior: Exterior Covering

Wood trim/fascia and soffit components at the roof edges and wall intersections on the North East corner exhibited signs of deterioration, including rot, openings, and gaps. These deficiencies can allow moisture intrusion and provide entry points for insects, birds, and other pests while contributing to further deterioration of the surrounding materials. Recommend repair or replacement of the damaged components, sealing of all openings, and evaluation of adjacent materials for concealed moisture damage by a qualified contractor.

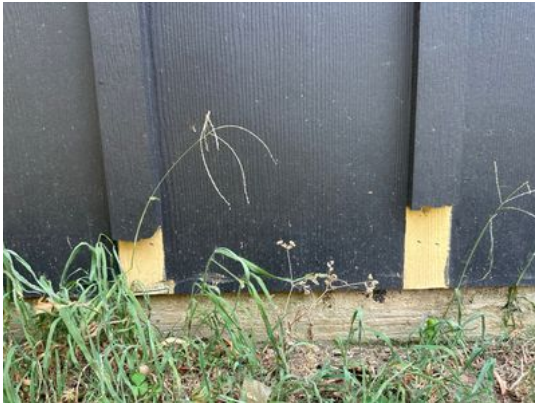
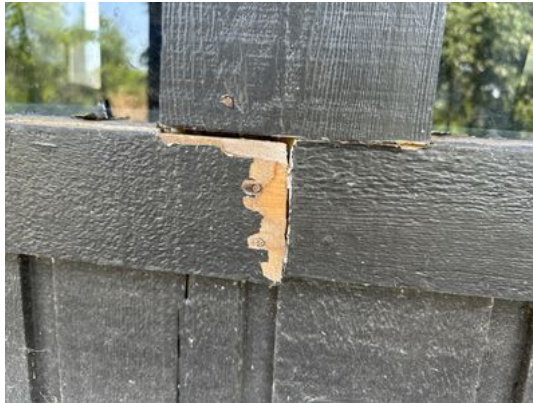
### Exterior: Exterior Covering

The exterior wall covering, trim, and associated exterior finish components exhibit areas of deterioration, damage, and/or improper installation. These conditions may allow moisture intrusion, accelerate material deterioration, and reduce the ability of the exterior envelope to protect the structure. Recommend evaluation and repair or replacement of all affected components by a qualified contractor. All repairs should be properly sealed, flashed where applicable, and finished to help prevent future moisture intrusion and deterioration. These problems pictured are on the North facing side of the house.

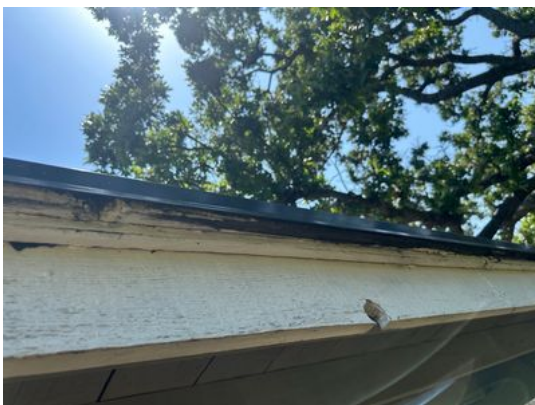
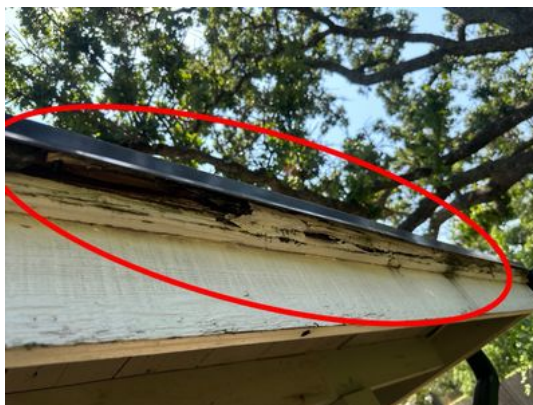
### Garage: Garage Type

Northwest corner of carport trim/fascia and soffit components are showing signs of rot and deterioration. Recommend repair.

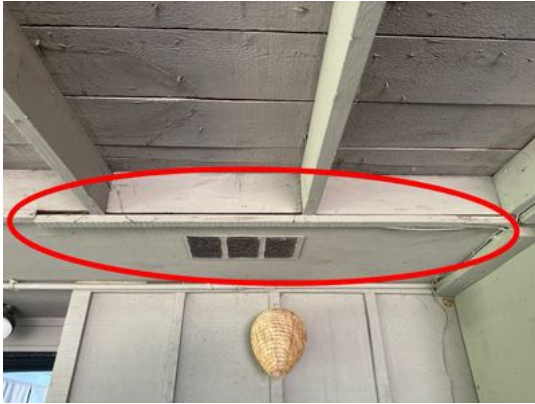
### Garage: Garage Type

Trim is beginning to show signs of deterioration and failure. Recommend repair or replacement.

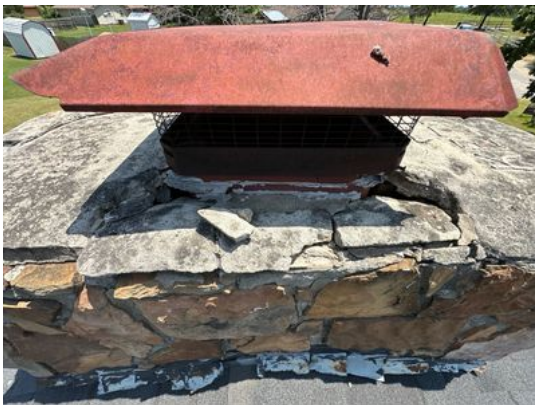
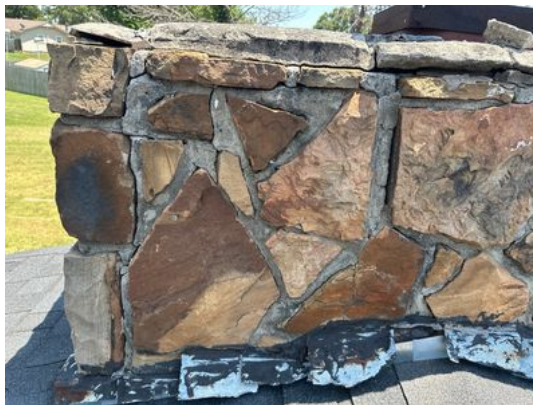
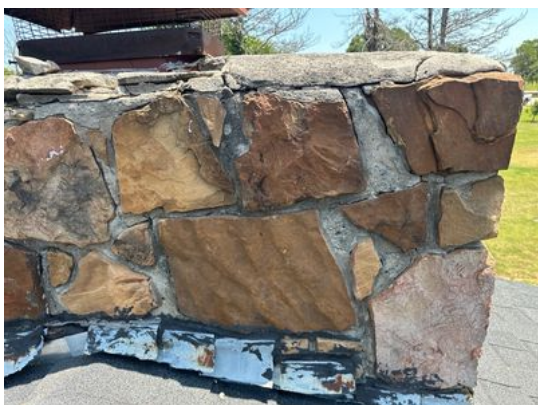
### Roofing: Chimney

The chimney crown exhibits cracking and deterioration. The damaged crown may allow water intrusion into the chimney structure, leading to further deterioration. Recommend evaluation and repair by a qualified chimney contractor.

Mortar joints within the chimney exhibit deterioration and cracking. Damaged mortar can permit moisture intrusion and contribute to continued deterioration. Recommend tuck-pointing or repairs by a qualified masonry contractor.

Flashing at the chimney base exhibits corrosion and signs of previous repairs. Deteriorated flashing may permit water intrusion. Recommend repair or replacement by a qualified roofing contractor.

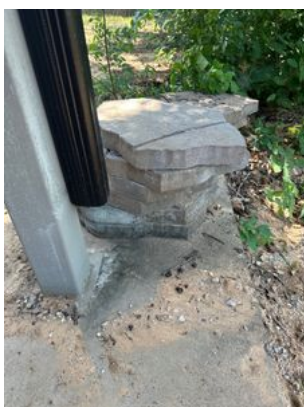
### Roofing: Gutters & Downspouts

The gutter downspout terminates adjacent to the structure without an extension to direct water away from the foundation. This condition can contribute to excessive moisture accumulation, soil erosion, and potential foundation movement over time. Recommend installing a downspout extension or other approved drainage method to discharge water several feet away from the foundation.

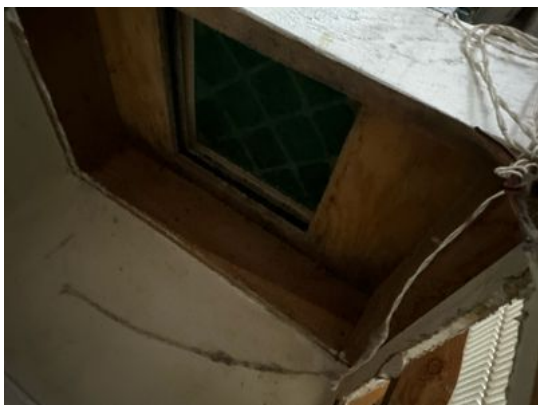
### HVAC: Cooling: AC Supply Air Temp

The supply plenum/ductwork was not connected to the air handler at the time of the inspection. As a result, conditioned air is not being properly distributed throughout the home. This condition can significantly impact the performance and efficiency of the HVAC system. Recommend evaluation and repair by a qualified HVAC contractor.

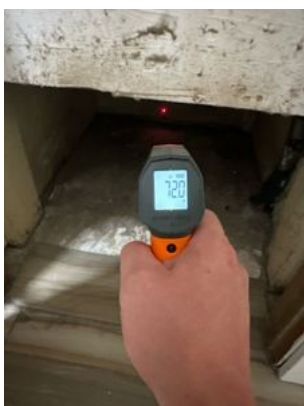
### HVAC: Cooling #2: AC Supply Air Temp

The supply plenum/ductwork was not connected to the air handler at the time of the inspection. As a result, conditioned air is not being properly distributed throughout the home. This condition can significantly impact the performance and efficiency of the HVAC system. Recommend evaluation and repair by a qualified HVAC contractor.
