First Due Home Inspections, LLC  
(580) 369-1105  
FirstDueHomeInspectors.com  
FDHInspections@gmail.com

## Home Inspection Report

123 Example St  
Oklahoma City, OK 73130

Inspected By: Payton Webber

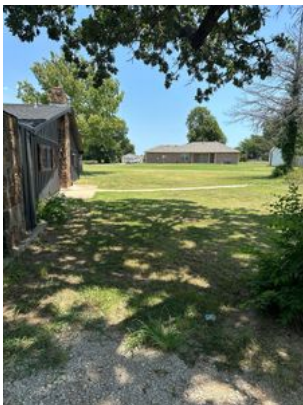
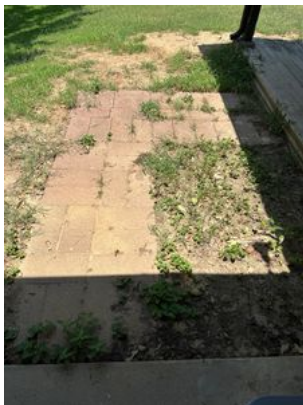
### Comment 1

Condition: Repair or Replace

Walkways do not extend from the home to the designated parking area. This condition may require occupants to walk across unprotected ground, which can become muddy, uneven, or slippery during wet weather. Consider extending the walkway to provide a safer and more convenient path of travel.

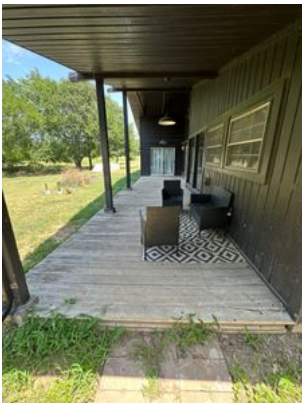
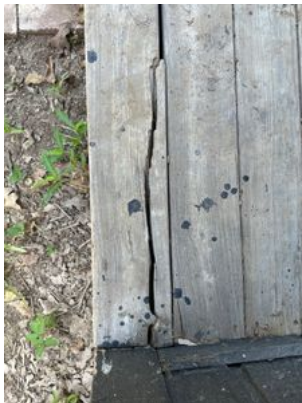
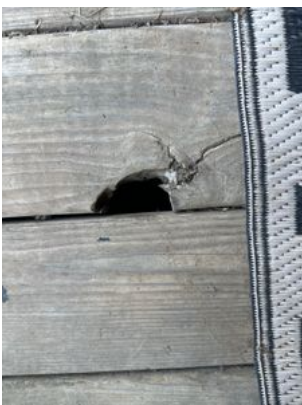
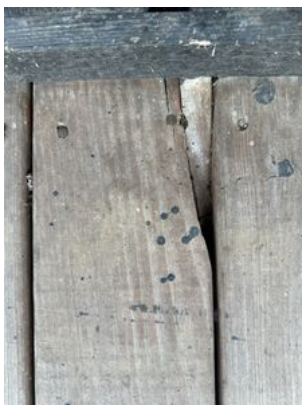
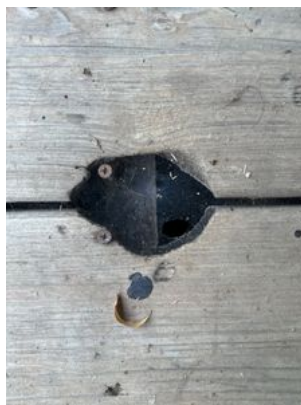
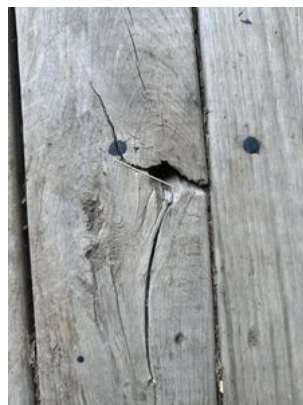
**Comment 4**

Condition: Repair or Replace

The exterior patio/deck surface is bowed/sagging toward the center, and multiple deck boards are loose. These conditions may indicate structural movement or deterioration and present a potential trip hazard. Recommend evaluation and repair by a qualified contractor to restore proper support and secure all loose decking components.

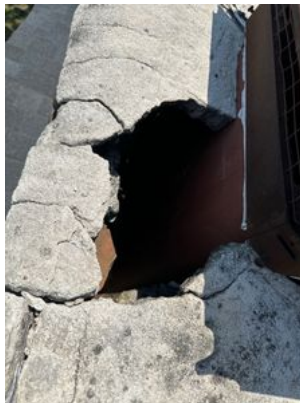
Mortar joints within the chimney exhibit deterioration and cracking. Damaged mortar can permit moisture intrusion and contribute to continued deterioration. Recommend tuck-pointing or repairs by a qualified masonry contractor.

Flashing at the chimney base exhibits corrosion and signs of previous repairs. Deteriorated flashing may permit water intrusion. Recommend repair or replacement by a qualified roofing contractor.

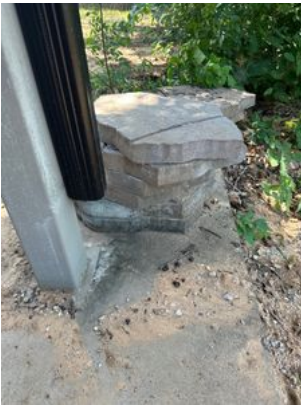
The gutter downspout terminates adjacent to the structure without an extension to direct water away from the foundation. This condition can contribute to excessive moisture accumulation, soil erosion, and potential foundation movement over time. Recommend installing a downspout extension or other approved drainage method to discharge water several feet away from the foundation.

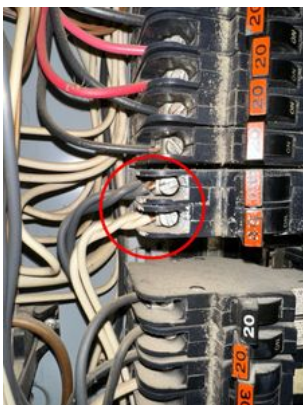
Two breakers were observed with two conductors terminated under a single breaker lug (double-tapped). Unless specifically listed by the manufacturer for multiple conductors, this installation is considered improper and may result in loose electrical connections, overheating, or arcing. Recommend evaluation and correction by a qualified licensed electrician.

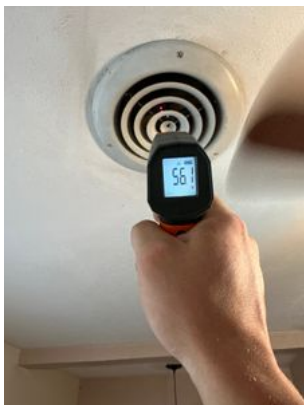
##### Comment 23 Information

The supply plenum/ductwork was not connected to the air handler at the time of the inspection. As a result, conditioned air is not being properly distributed throughout the home. This condition can significantly impact the performance and efficiency of the HVAC system. Recommend evaluation and repair by a qualified HVAC contractor.

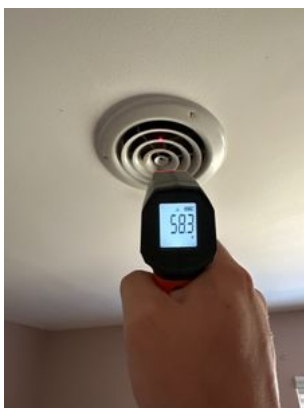
#### Comment 26

The supply plenum/ductwork was not connected to the air handler at the time of the inspection. As a result, conditioned air is not being properly distributed throughout the home. This condition can significantly impact the performance and efficiency of the HVAC system. Recommend evaluation and repair by a qualified HVAC contractor.

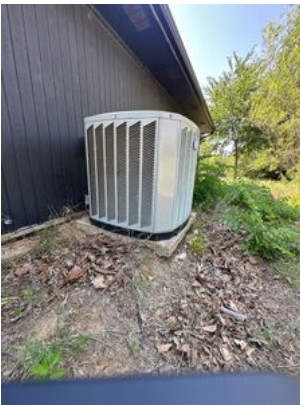
The outdoor heat pump pad has settled and is no longer providing a stable, level base. Additionally, grading around the unit has deteriorated, allowing soil erosion and inadequate support beneath the pad. This condition may contribute to equipment movement, stress on refrigerant lines and electrical connections, and reduced service life. Recommend regrading the area and resetting or replacing the equipment pad as needed by a qualified HVAC contractor.

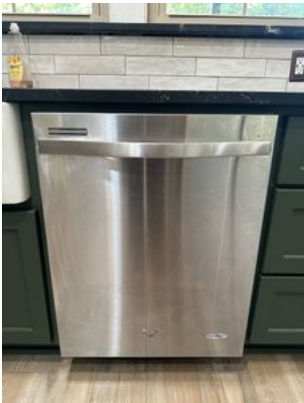
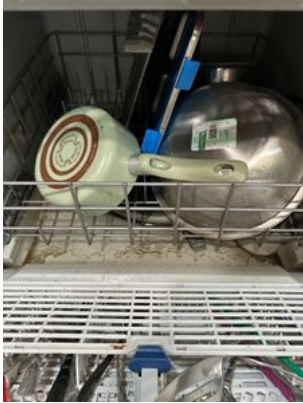
### Dishwasher

Standing water was observed in the bottom of the dishwasher at the time of the inspection. This condition may indicate restricted drainage, a clogged filter or drain hose, a drain pump issue, or an installation-related problem. Recommend further evaluation and any necessary repairs by a qualified appliance technician to ensure the dishwasher drains properly.

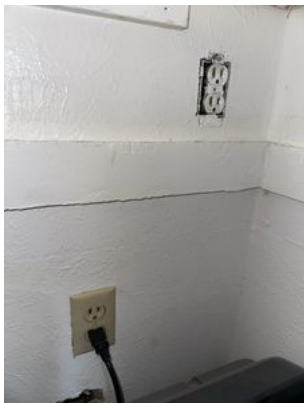
## GFCI Protection

No GFCI protection was present for the laundry area receptacle(s) at the time of the inspection. Current safety standards require GFCI protection for receptacles in laundry areas to reduce the risk of electrical shock. Recommend installation of GFCI-protected receptacle(s) or circuit protection by a qualified electrician.

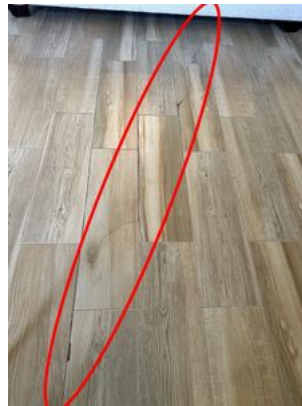
A crack was observed in the tile flooring extending a significant distance across the floor. The crack remained relatively consistent in width with no significant vertical displacement observed at the time of the inspection. The cause of the cracking could not be determined during this visual inspection. Recommend monitoring for additional movement. If the crack widens, develops vertical displacement, or additional signs of movement are observed, further evaluation by a qualified foundation or structural professional is recommended.

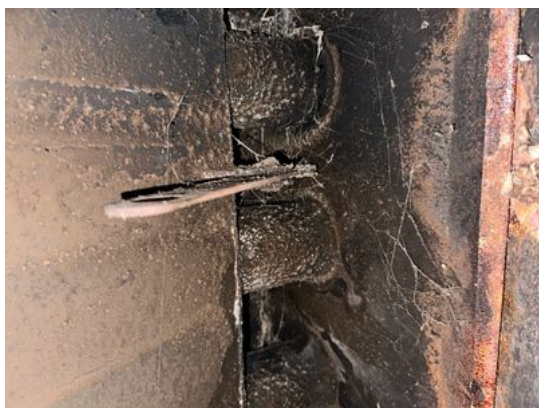
Separation was observed between the stone fireplace surround and the adjacent wood trim/finish. This condition is likely the result of normal differential movement between dissimilar building materials but may allow air and moisture intrusion and detracts from the finished appearance. Recommend sealing or repairing the separation as needed and monitoring for any signs of continued movement or widening. If significant movement is observed, further evaluation by a qualified contractor is recommended.

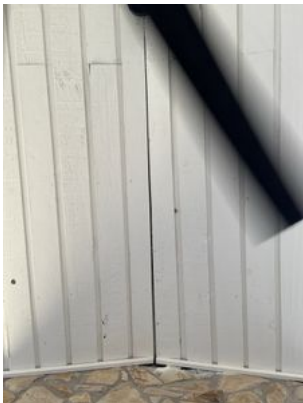
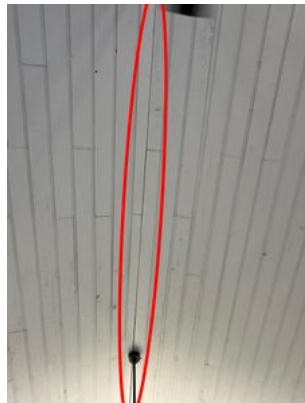
##### Comment 40

A linear separation was observed along a ceiling panel joint in the vaulted living room ceiling. The separation appeared straight and generally uniform in width, with no significant displacement noted at the time of the inspection. This condition is consistent with typical movement that can occur from normal settlement and/or seasonal expansion and contraction. Recommend monitoring for any increase in width, displacement, or additional cracking. If significant changes are observed, further evaluation by a qualified contractor is recommended.

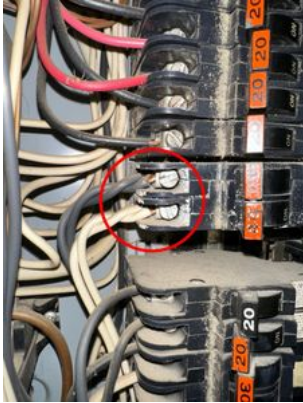
### Electrical

Two breakers were observed with two conductors terminated under a single breaker lug (double-tapped). Unless specifically listed by the manufacturer for multiple conductors, this installation is considered improper and may result in loose electrical connections, overheating, or arcing. Recommend evaluation and correction by a qualified licensed electrician.

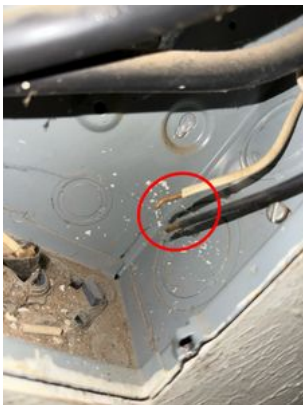
### Electrical

Loose/unterminated conductors were observed within the electrical panel enclosure. Unsecured conductors may present a shock hazard if energized and can indicate incomplete or abandoned wiring. Recommend evaluation by a qualified licensed electrician to determine whether the conductors are energized and to properly terminate, remove, or safely cap them as needed.

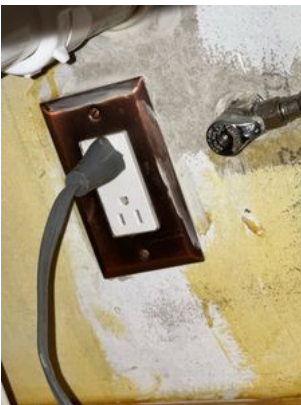
### **Kitchen: Sink**

No GFCI protection was present for the required kitchen countertop receptacle(s) at the time of the inspection. GFCI protection is an important safety feature designed to reduce the risk of electrical shock in areas where water is commonly present. Recommend installation of GFCI-protected receptacles or circuit protection by a qualified electrician.

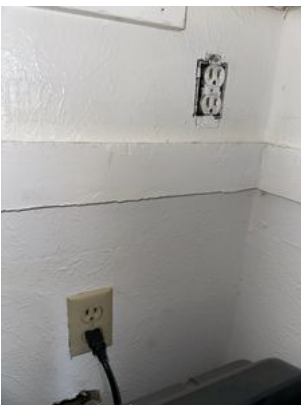
### **Laundry: GFCI Protection**

No GFCI protection was present for the laundry area receptacle(s) at the time of the inspection. Current safety standards require GFCI protection for receptacles in laundry areas to reduce the risk of electrical shock. Recommend installation of GFCI-protected receptacle(s) or circuit protection by a qualified electrician.

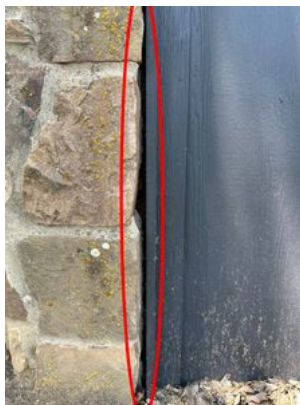
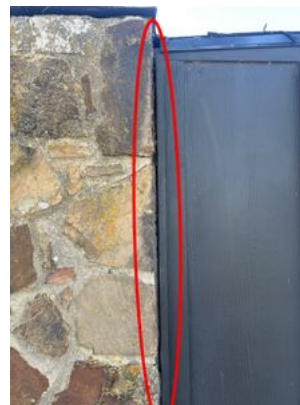
#### Exterior: Exterior Covering

The exterior wall covering, trim, and associated exterior finish components exhibit areas of deterioration, damage, and/or improper installation. These conditions may allow moisture intrusion, accelerate material deterioration, and reduce the ability of the exterior envelope to protect the structure. Recommend evaluation and repair or replacement of all affected components by a qualified contractor. All repairs should be properly sealed, flashed where applicable, and finished to help prevent future moisture intrusion and deterioration. These problems pictured are on the South facing side of the house.

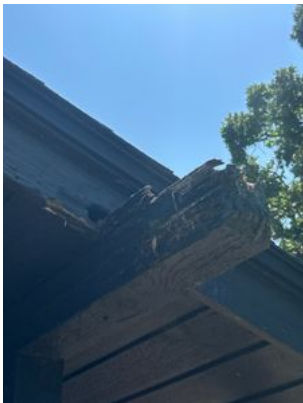
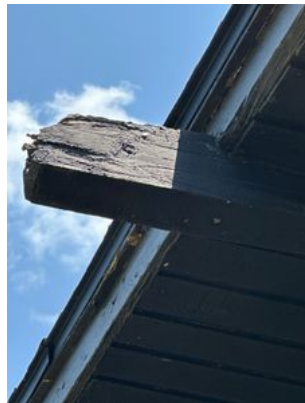
### Exterior: Exterior Covering

The exterior wall covering, trim, and associated exterior finish components exhibit areas of deterioration, damage, and/or improper installation. These conditions may allow moisture intrusion, accelerate material deterioration, and reduce the ability of the exterior envelope to protect the structure. Recommend evaluation and repair or replacement of all affected components by a qualified contractor. All repairs should be properly sealed, flashed where applicable, and finished to help prevent future moisture intrusion and deterioration. These problems pictured are on the North facing side of the house.

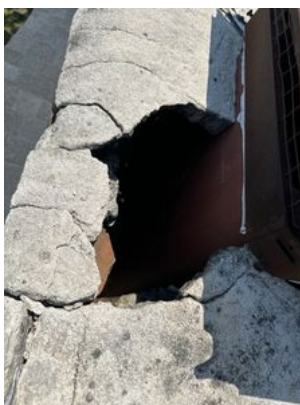
The chimney crown exhibits cracking and deterioration. The damaged crown may allow water intrusion into the chimney structure, leading to further deterioration. Recommend evaluation and repair by a qualified chimney contractor.

Mortar joints within the chimney exhibit deterioration and cracking. Damaged mortar can permit moisture intrusion and contribute to continued deterioration. Recommend tuck-pointing or repairs by a qualified masonry contractor.

Flashing at the chimney base exhibits corrosion and signs of previous repairs. Deteriorated flashing may permit water intrusion. Recommend repair or replacement by a qualified roofing contractor.

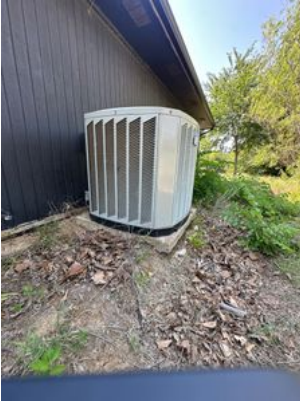
### HVAC: Cooling #2

The outdoor heat pump pad has settled and is no longer providing a stable, level base. Additionally, grading around the unit has deteriorated, allowing soil erosion and inadequate support beneath the pad. This condition may contribute to equipment movement, stress on refrigerant lines and electrical connections, and reduced service life. Recommend regrading the area and resetting or replacing the equipment pad as needed by a qualified HVAC contractor.

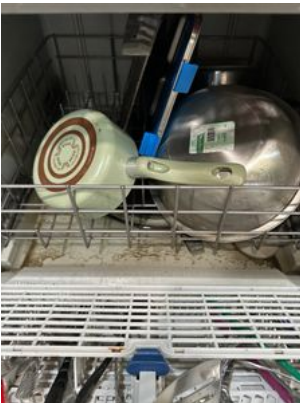
### Kitchen: Appliances: Dishwasher

Standing water was observed in the bottom of the dishwasher at the time of the inspection. This condition may indicate restricted drainage, a clogged filter or drain hose, a drain pump issue, or an installation-related problem. Recommend further evaluation and any necessary repairs by a qualified appliance technician to ensure the dishwasher drains properly.

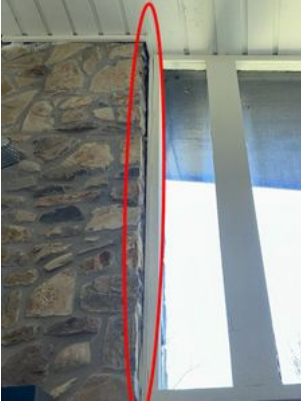
Separation was observed between the stone fireplace surround and the adjacent wood trim/finish. This condition is likely the result of normal differential movement between dissimilar building materials but may allow air and moisture intrusion.

and detracts from the finished appearance. Recommend sealing or repairing the separation as needed and monitoring for any signs of continued movement or widening. If significant movement is observed, further evaluation by a qualified contractor is recommended.
