First Due Home Inspections, LLC
(580) 369-1105

Home Inspection Report
123 Example St
Oklahoma City, OK 73130

Prepared For: Demo Dan
Inspected On Tue, May 26, 2026 at 8:00 AM

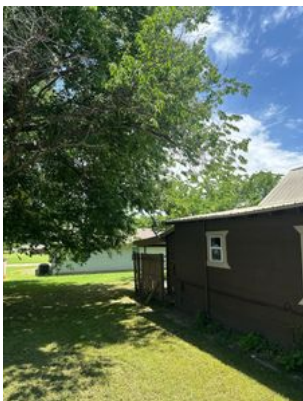
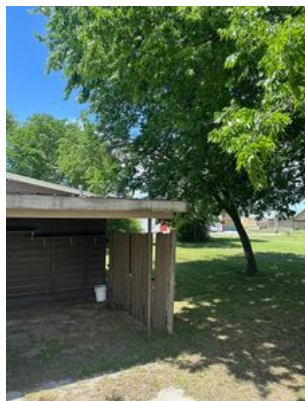
Generally Overgrown

Condition: Needs to be cut back and trimmed.

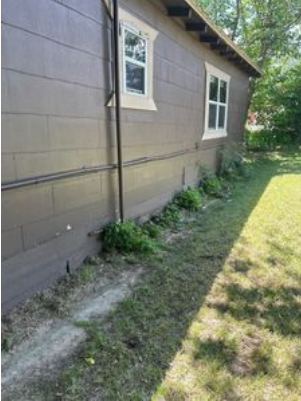
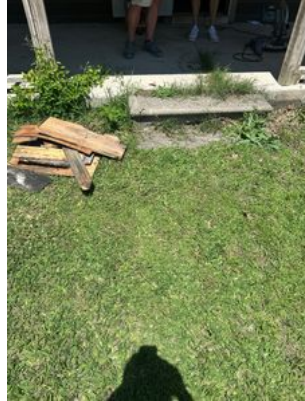
Comment 2

Monitor Condition

Recommend monitoring overgrowth around perimeter of home.

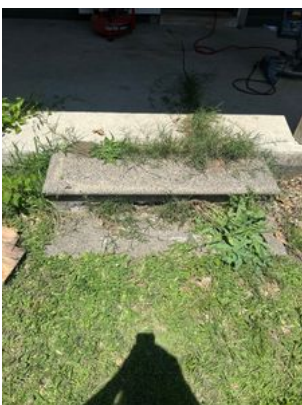
Comment 3
Safety Concern

Further evaluation due to no landing. Recommend a landing outside exterior door.

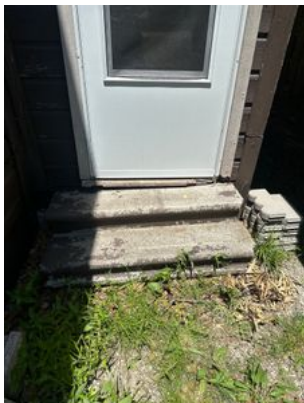
Comment 4
Safety Concern

Steps entering the structure have observed overgrowth. This poses a trip hazard.

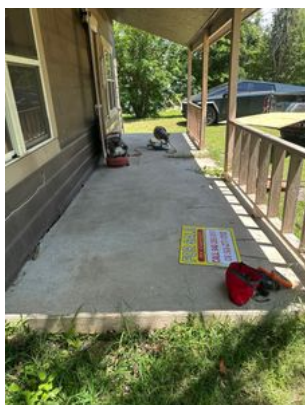
Comment 5

Repair or Replacement Needed

The grading slopes toward the home and will not shed water away from the home. This is a common cause of wet crawl spaces and leaking basements. Suggest adding fill dirt at low areas to prevent water from sitting next to home. Recommend further evaluation.

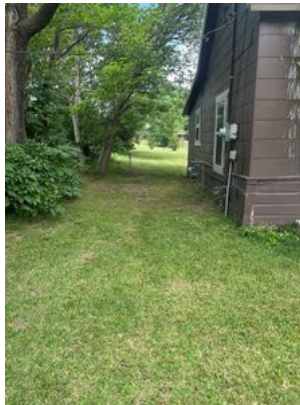
Comment 6

Repair or Replacement Needed

Observed wash-out on the North West corner of structure. Recommend further evaluation.

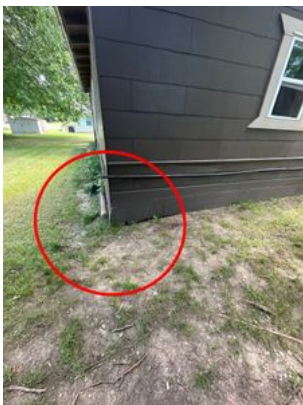
Comment 7

Monitor Condition

Site slopes towards structure on the North side of the property.

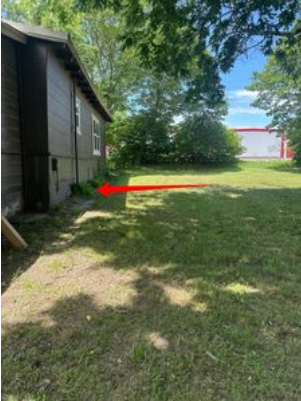
Comment 8

Repair or Replacement Needed

Appears to show signs of wash out and potentially water entering crawlspace of structure. Recommend further evaluation.

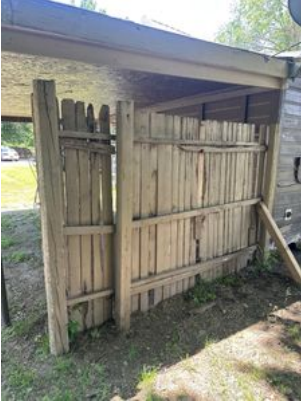
Repair or Replacement Needed

South side of home on the patio appears to have rotting.

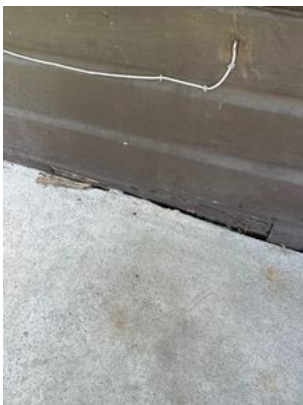
Comment 12

Repair or Replacement Needed

Southwest corner of structure. Observed rotting.

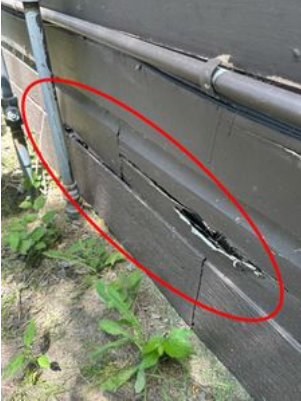
Comment 16

Repair or Replacement Needed

Observed rotting and possible pest entrance on Northeast side of structure.

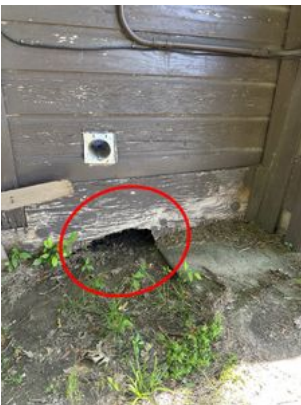
Comment 17

Repair or Replacement Needed

Splitting and rotting observed on east side of home near back door. Recommend further evaluation or replacement.

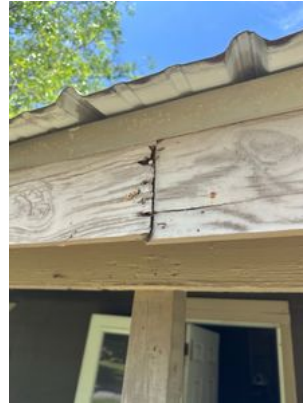
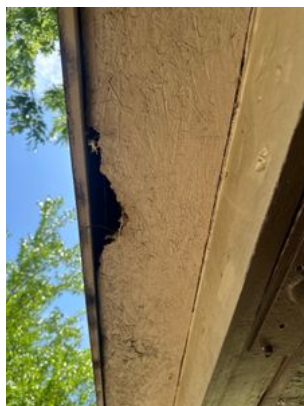
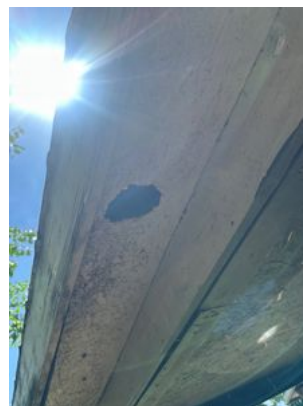
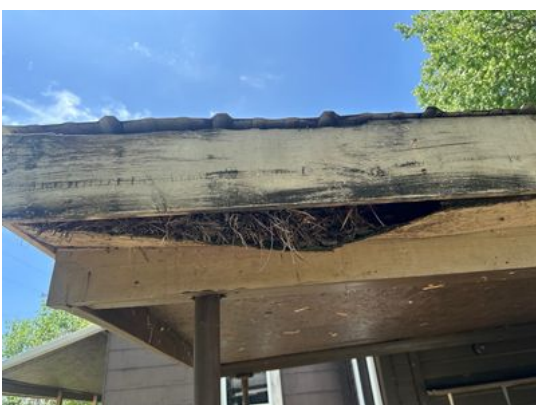
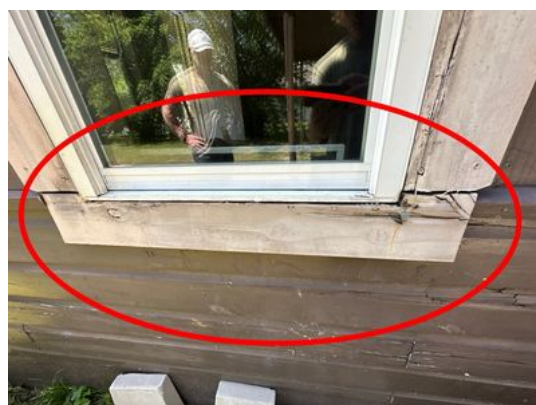
Comment 18

Repair or Replacement Needed

Observed multiple damaged exterior trim showing signs of deterioration. Recommend repair or replacement.

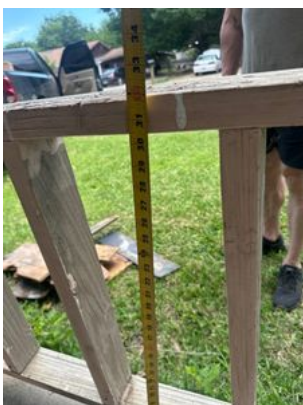
Comment 22

Repair or Replacement Needed

Railings appear to be too short and spacing between balusters are too wide. Recommend further evaluation.

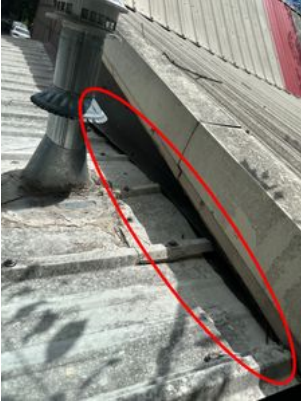
Repair or Replacement Needed

Northeast corner of structure. Sheet metal appears to be above the flashing. Recommend further evaluation or repair.

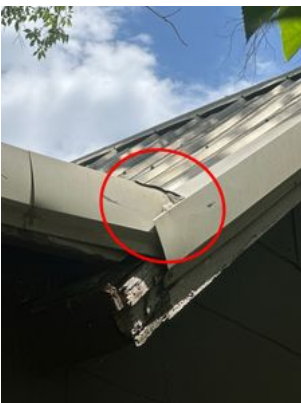
Monitor Condition

Flashing does not appear sufficient. Recommend further evaluation.

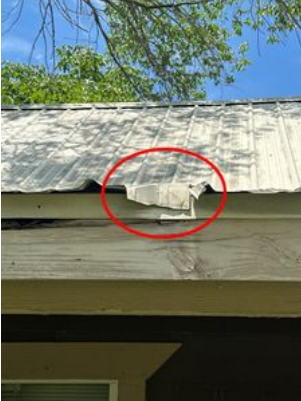
Comment 28
Information

South side of house. Cosmetic issue.

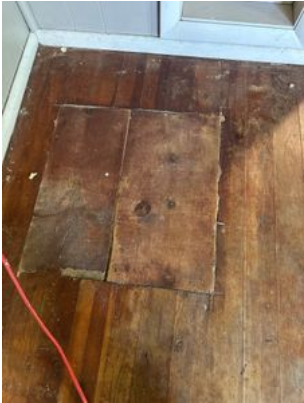
Comment 29 Information

Did not inspect crawl space. Inaccessible.

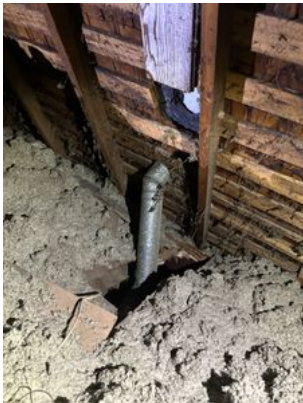
Repair or Replacement Needed

Vent does not appear to vent to exterior. Recommend further evaluation.

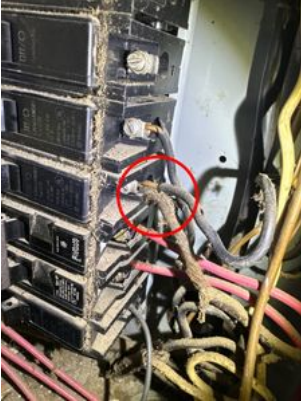
Comment 35

Safety Concern

Double tapped breaker. This is a safety concern. Recommend repair by a licensed electrician.

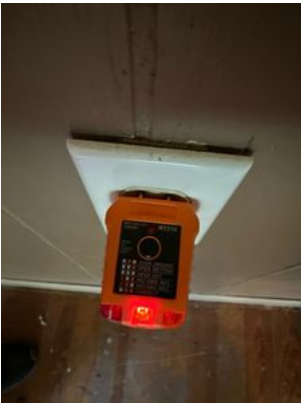
Comment 36

Repair or Replacement Needed

Observed open ground in all receptacles. Plug cover is loose in master bedroom.

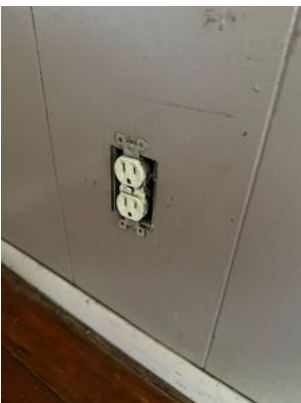
Comment 37

Repair or Replacement Needed

Missing cover plate in living room.

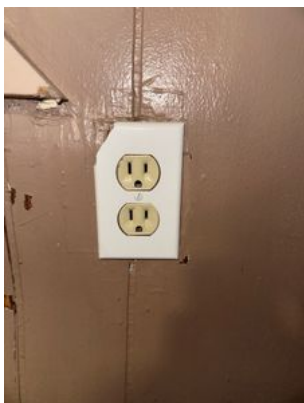
Comment 39

Repair or Replacement Needed

Broken receptacle cover in the middle bedroom north side of house.

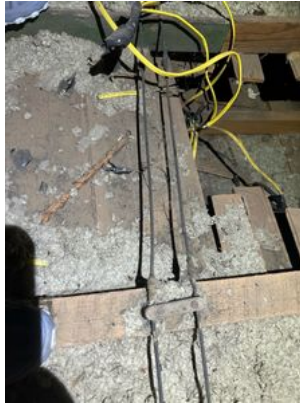
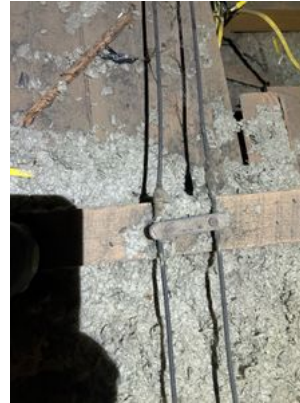
Comment 40
Safety Concern

Knob and tube wiring and open splices were observed. Recommend repair by a licensed electrician.

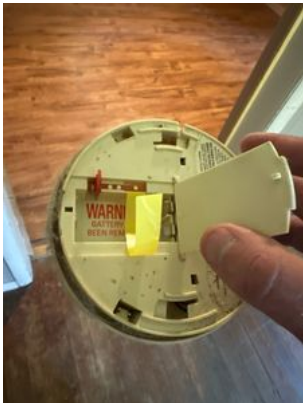
**Comment 41
Safety Concern**

No batteries in smoke detector.

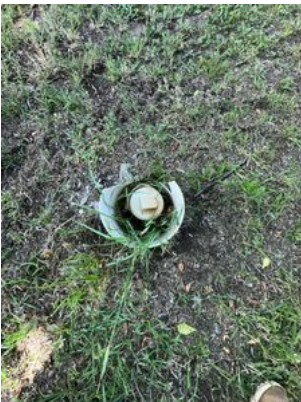
Comment 47 Information

Waste clean out. Northeast side of yard.

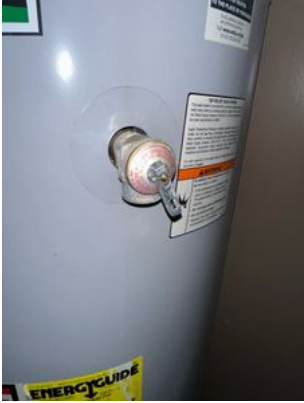
Present without blow off leg

Condition: Repair or Replace

Comment 48
Safety Concern

No blow-off leg present. Recommend repair by a licensed plumber.

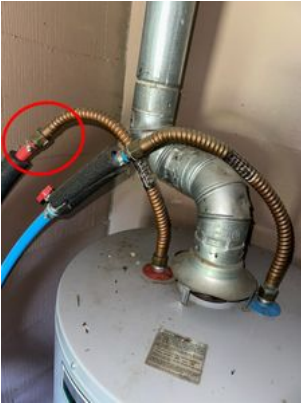
Repair or Replacement Needed

No hot water shut off. Recommend repair or replacement.

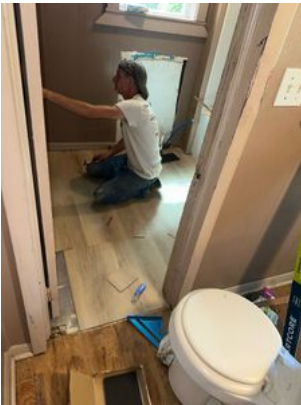
Comment 51 Information

Under construction day of inspections.

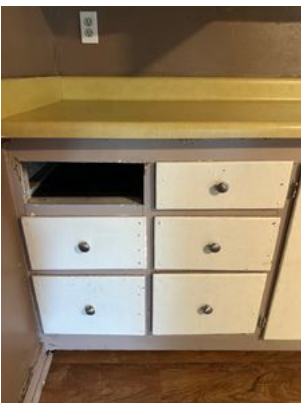
Monitor Condition

Missing drawer. Recommend replacing.

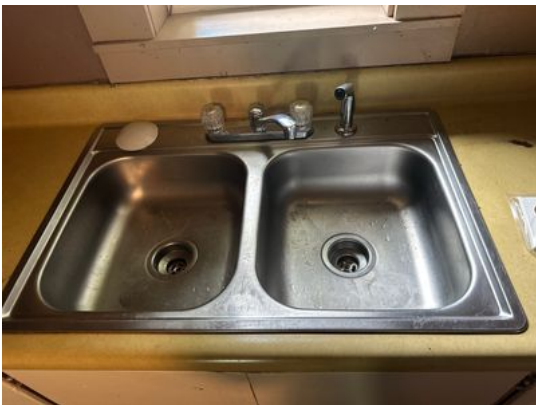
Comment 54

Safety Concern

Kitchen sink water temperature is above the recommended temperature. Water temperature inside a house is recommended to not be above 120 degrees Fahrenheit to prevent scolding.

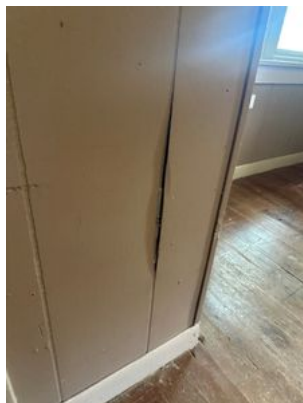
Comment 57

Repair or Replacement Needed

Multiple walls observed defects. Recommend repair or replacement.

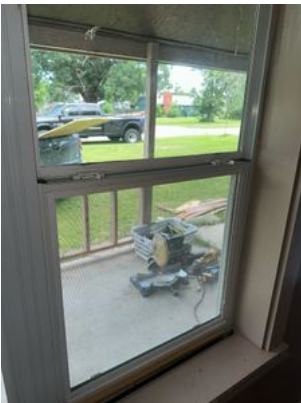
Repair or Replacement Needed

Southeast front window will not remain open. Recommend repair.

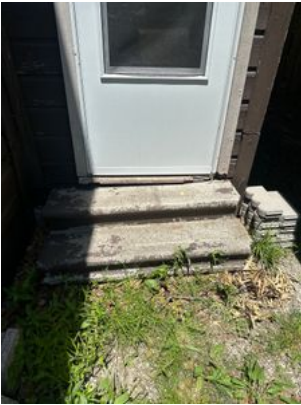
Site: Steps/Stoops

Further evaluation due to no landing. Recommend a landing outside exterior door.

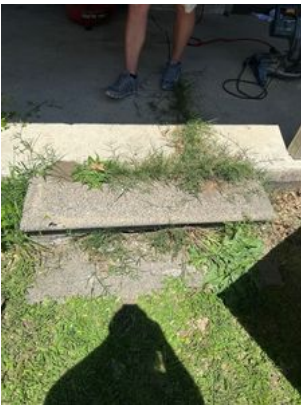
Site: Steps/Stoops

Steps entering the structure have observed overgrowth. This poses a trip hazard.

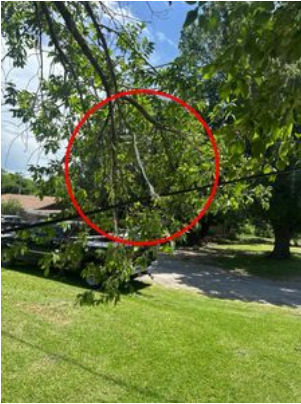
Site

Utility line is tied to a tree limb and is too low to the ground. Potential safety hazard. Recommend further evaluation.

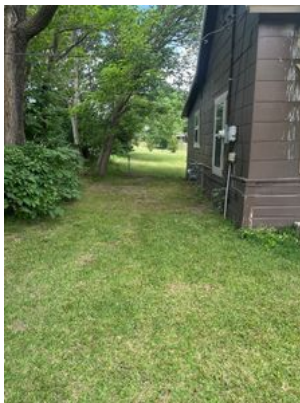
Site

The grading slopes toward the home and will not shed water away from the home. This is a common cause of wet crawl spaces and leaking basements. Suggest adding fill dirt at low areas to prevent water from sitting next to home. Recommend further evaluation.

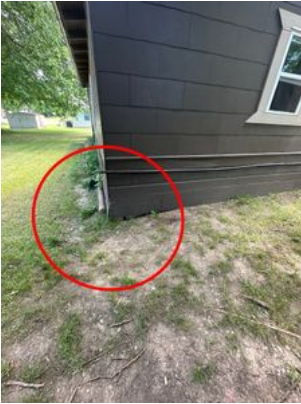
Site

Observed wash-out on the North West corner of structure. Recommend further evaluation.

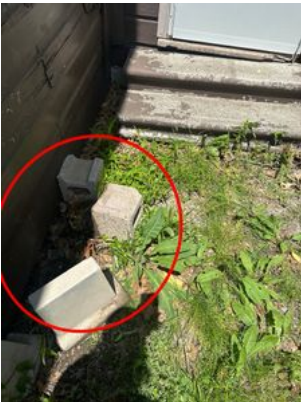
Site

Appears to show signs of wash out and potentially water entering crawlspace of structure. Recommend further evaluation.

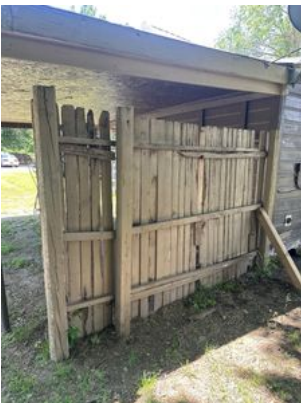
Site

Fence under carport is showing signs of deterioration. Recommend further evaluation or replacement.

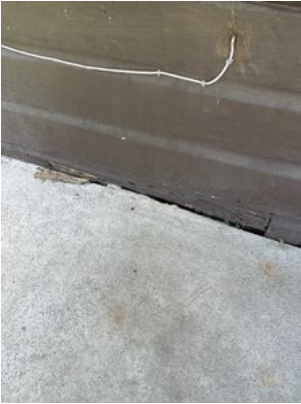
Exterior: Exterior Covering

South side of home on the patio appears to have rotting.

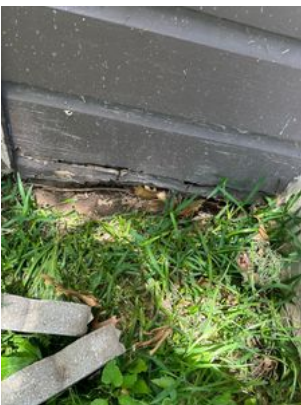
Exterior: Exterior Covering

Southwest corner of structure. Observed rotting.

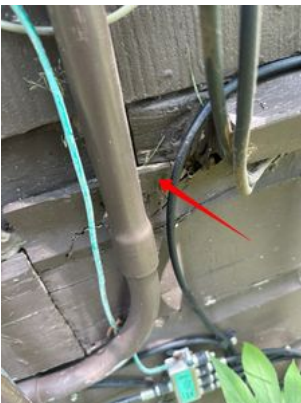
Exterior: Exterior Covering

Rotting observed below service entrance on west side of structure. Recommend further evaluation or repair.

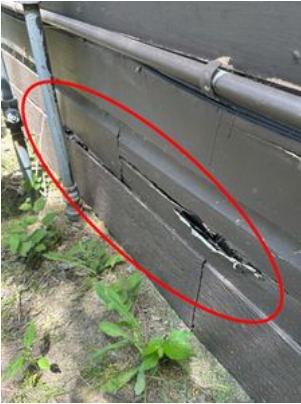
Exterior: Exterior Covering

Observed rotting on west side of structure near gas meter. Recommend further evaluation or repair.

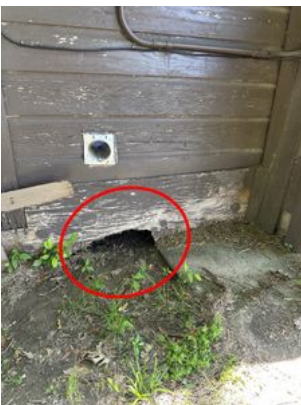
Exterior: Exterior Covering

Observed rotting and possible pest entrance on Northeast side of structure.

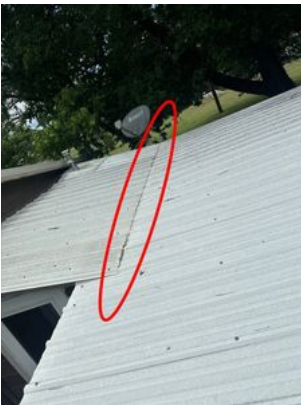
Roofing: Inspection Method

Carport Sealant is showing signs of deterioration. Recommend repair or replacement.

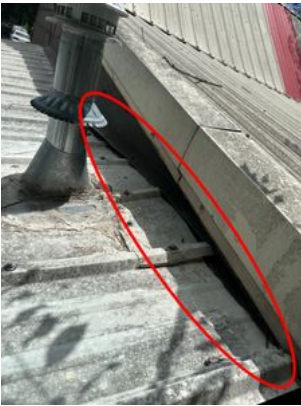
Roofing: Inspection Method

Northeast corner of structure. Sheet metal appears to be above the flashing. Recommend further evaluation or repair.

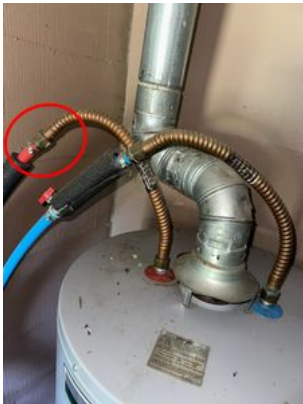
Plumbing: Water Heater

No hot water shut off. Recommend repair or replacement.

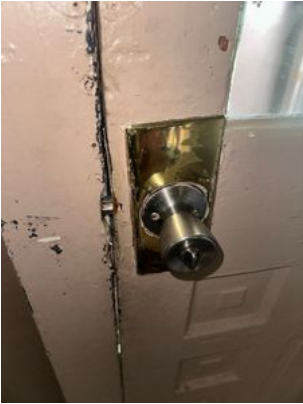
Interior: Entry Door Types

Kitchen door to laundry room will not latch and sags. Recommend repair.
